**STORMWATER MANAGEMENT PROGRAM
*FINAL REPORT***

**Submitted to:
UNIVERSITY OF MASSACHUSETTS LOWELL**

**Submitted by:
AMEC Earth & Environmental
Westford, Massachusetts**

March 5, 2009

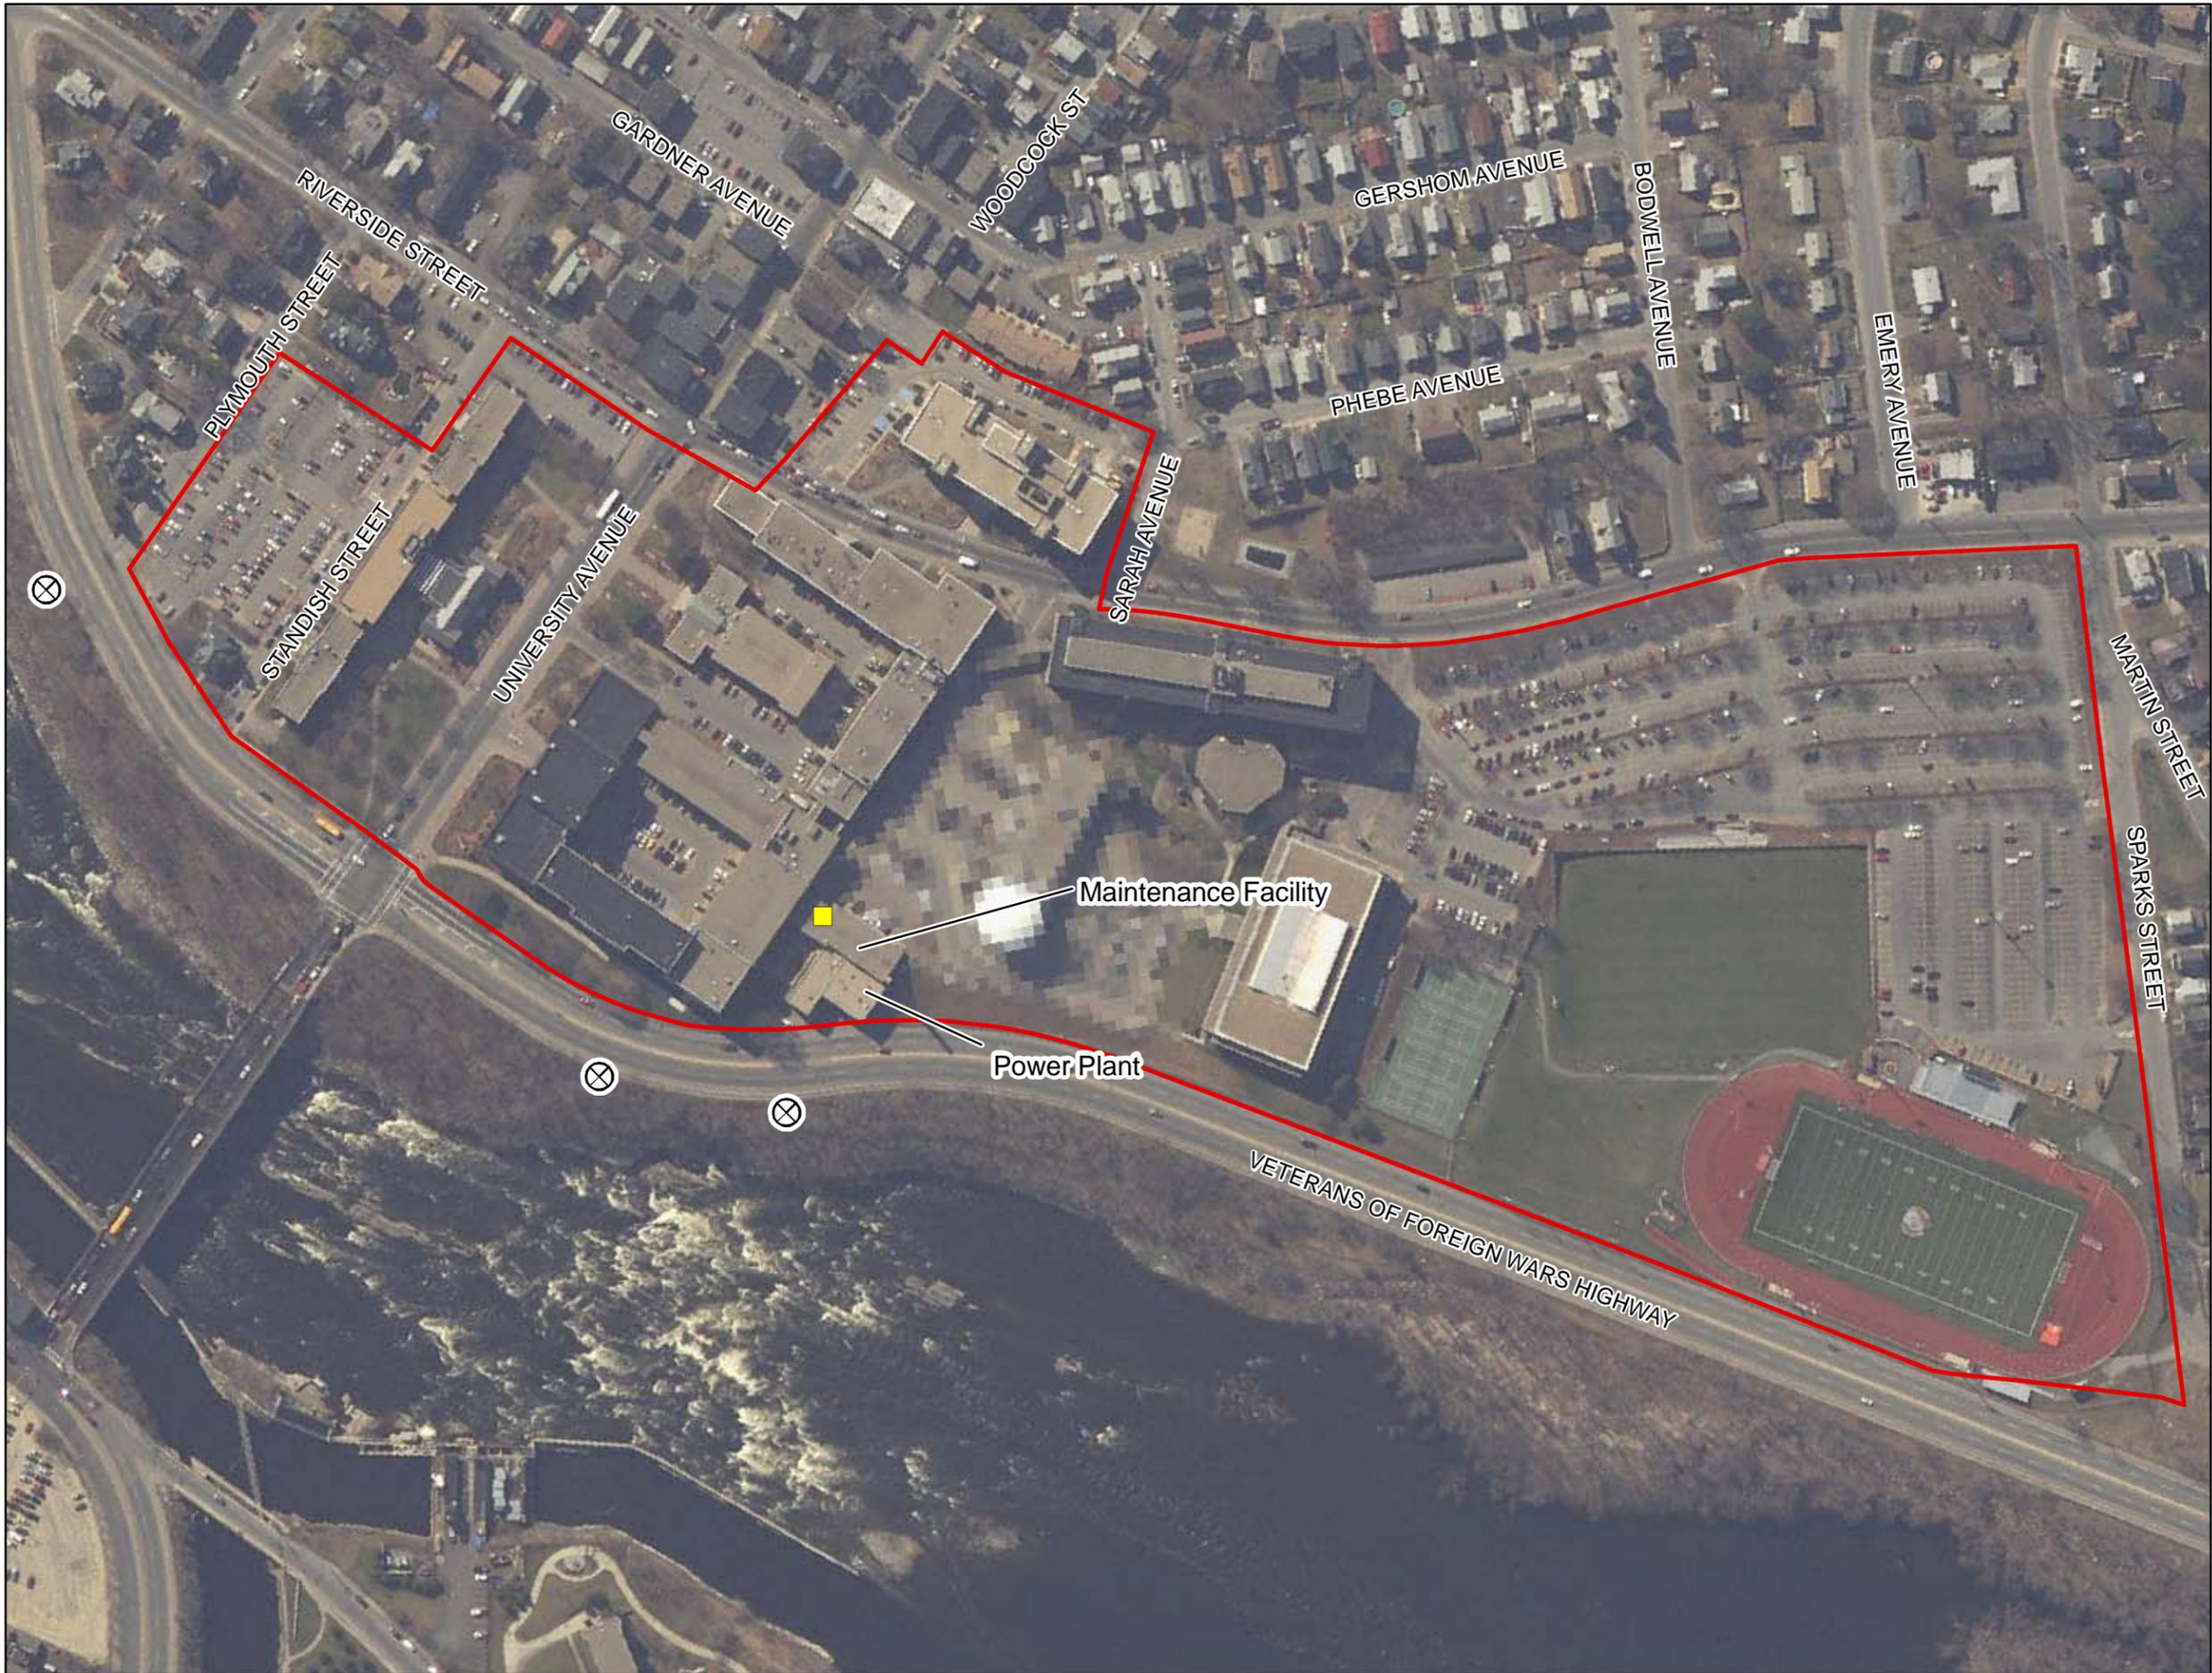
FIGURE 1

Stormwater runoff generated throughout the impervious areas of the North Campus flows over roof and pavement and is collected by internal roof leaders or catch basins, and conveyed to a stormwater drain or to a combined sewer. The University has recently completed separation of the combined sewer discharging into the City of Lowell sewer system on Riverside Street and VFW Highway. As a result, stormwater runoff from the southern part of the campus (Cumnock Hall, Southwick Hall, Falmouth Hall, Kitson Hall, Pasteur Hall, Ball Hall, Engineering Building, and surrounding parking areas) does not discharge into the combined sewer. A portion of the runoff directly infiltrates through three leaching basins installed under the Cumnock Hall parking lot. The overflow is connected to the municipal sewer on Riverside Street. The remaining stormwater runoff is conveyed through the stormwater drain and discharges into the Merrimack River at two locations. Both of these outfalls have been identified and are shown in Figure 1. Additionally, the City of Lowell has separated the Sparks Street combined sewer, and the Riverside Parking Lot was tied to the municipal stormwater drain. According to the drawings provided by the University, stormwater runoff from the library and adjacent buildings is collected via internal roof leaders and conveyed to a combined sewer on VFW Highway. Runoff from the parking lot on Standish Street is collected by catch basins located along the southern edge of the parking lot and conveyed through the stormwater drain, which ties into the municipal stormwater drain discharging into the Merrimack River through an outfall. Additional catch basins located on VFW Highway

are also tied to the municipal stormwater drain. Approximate location of the outfall has been identified on Figure 1.

North Campus
 University of Massachusetts
 at Lowell
 Lowell, MA

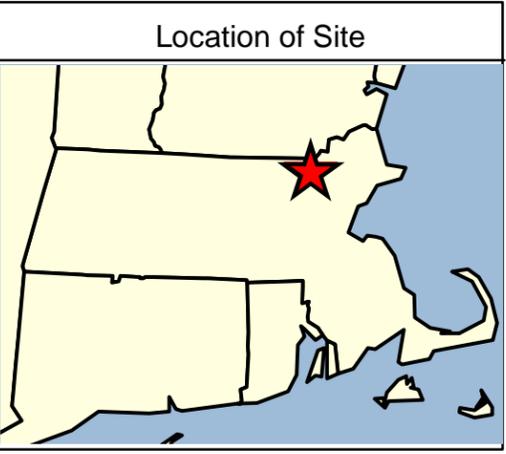
The North Campus is bounded by the VFW Highway to the southeast, Plymouth Street and Standish Street to the southwest, Riverside Street to the northwest, and Sparks Street to the northeast. The location of this site is shown in Figure 1. There are twelve classroom and administrative buildings, one gymnasium, soccer field, football field/track, library, two large parking lots, several small parking lots, maintenance garage facility, and a power plant located within the campus.

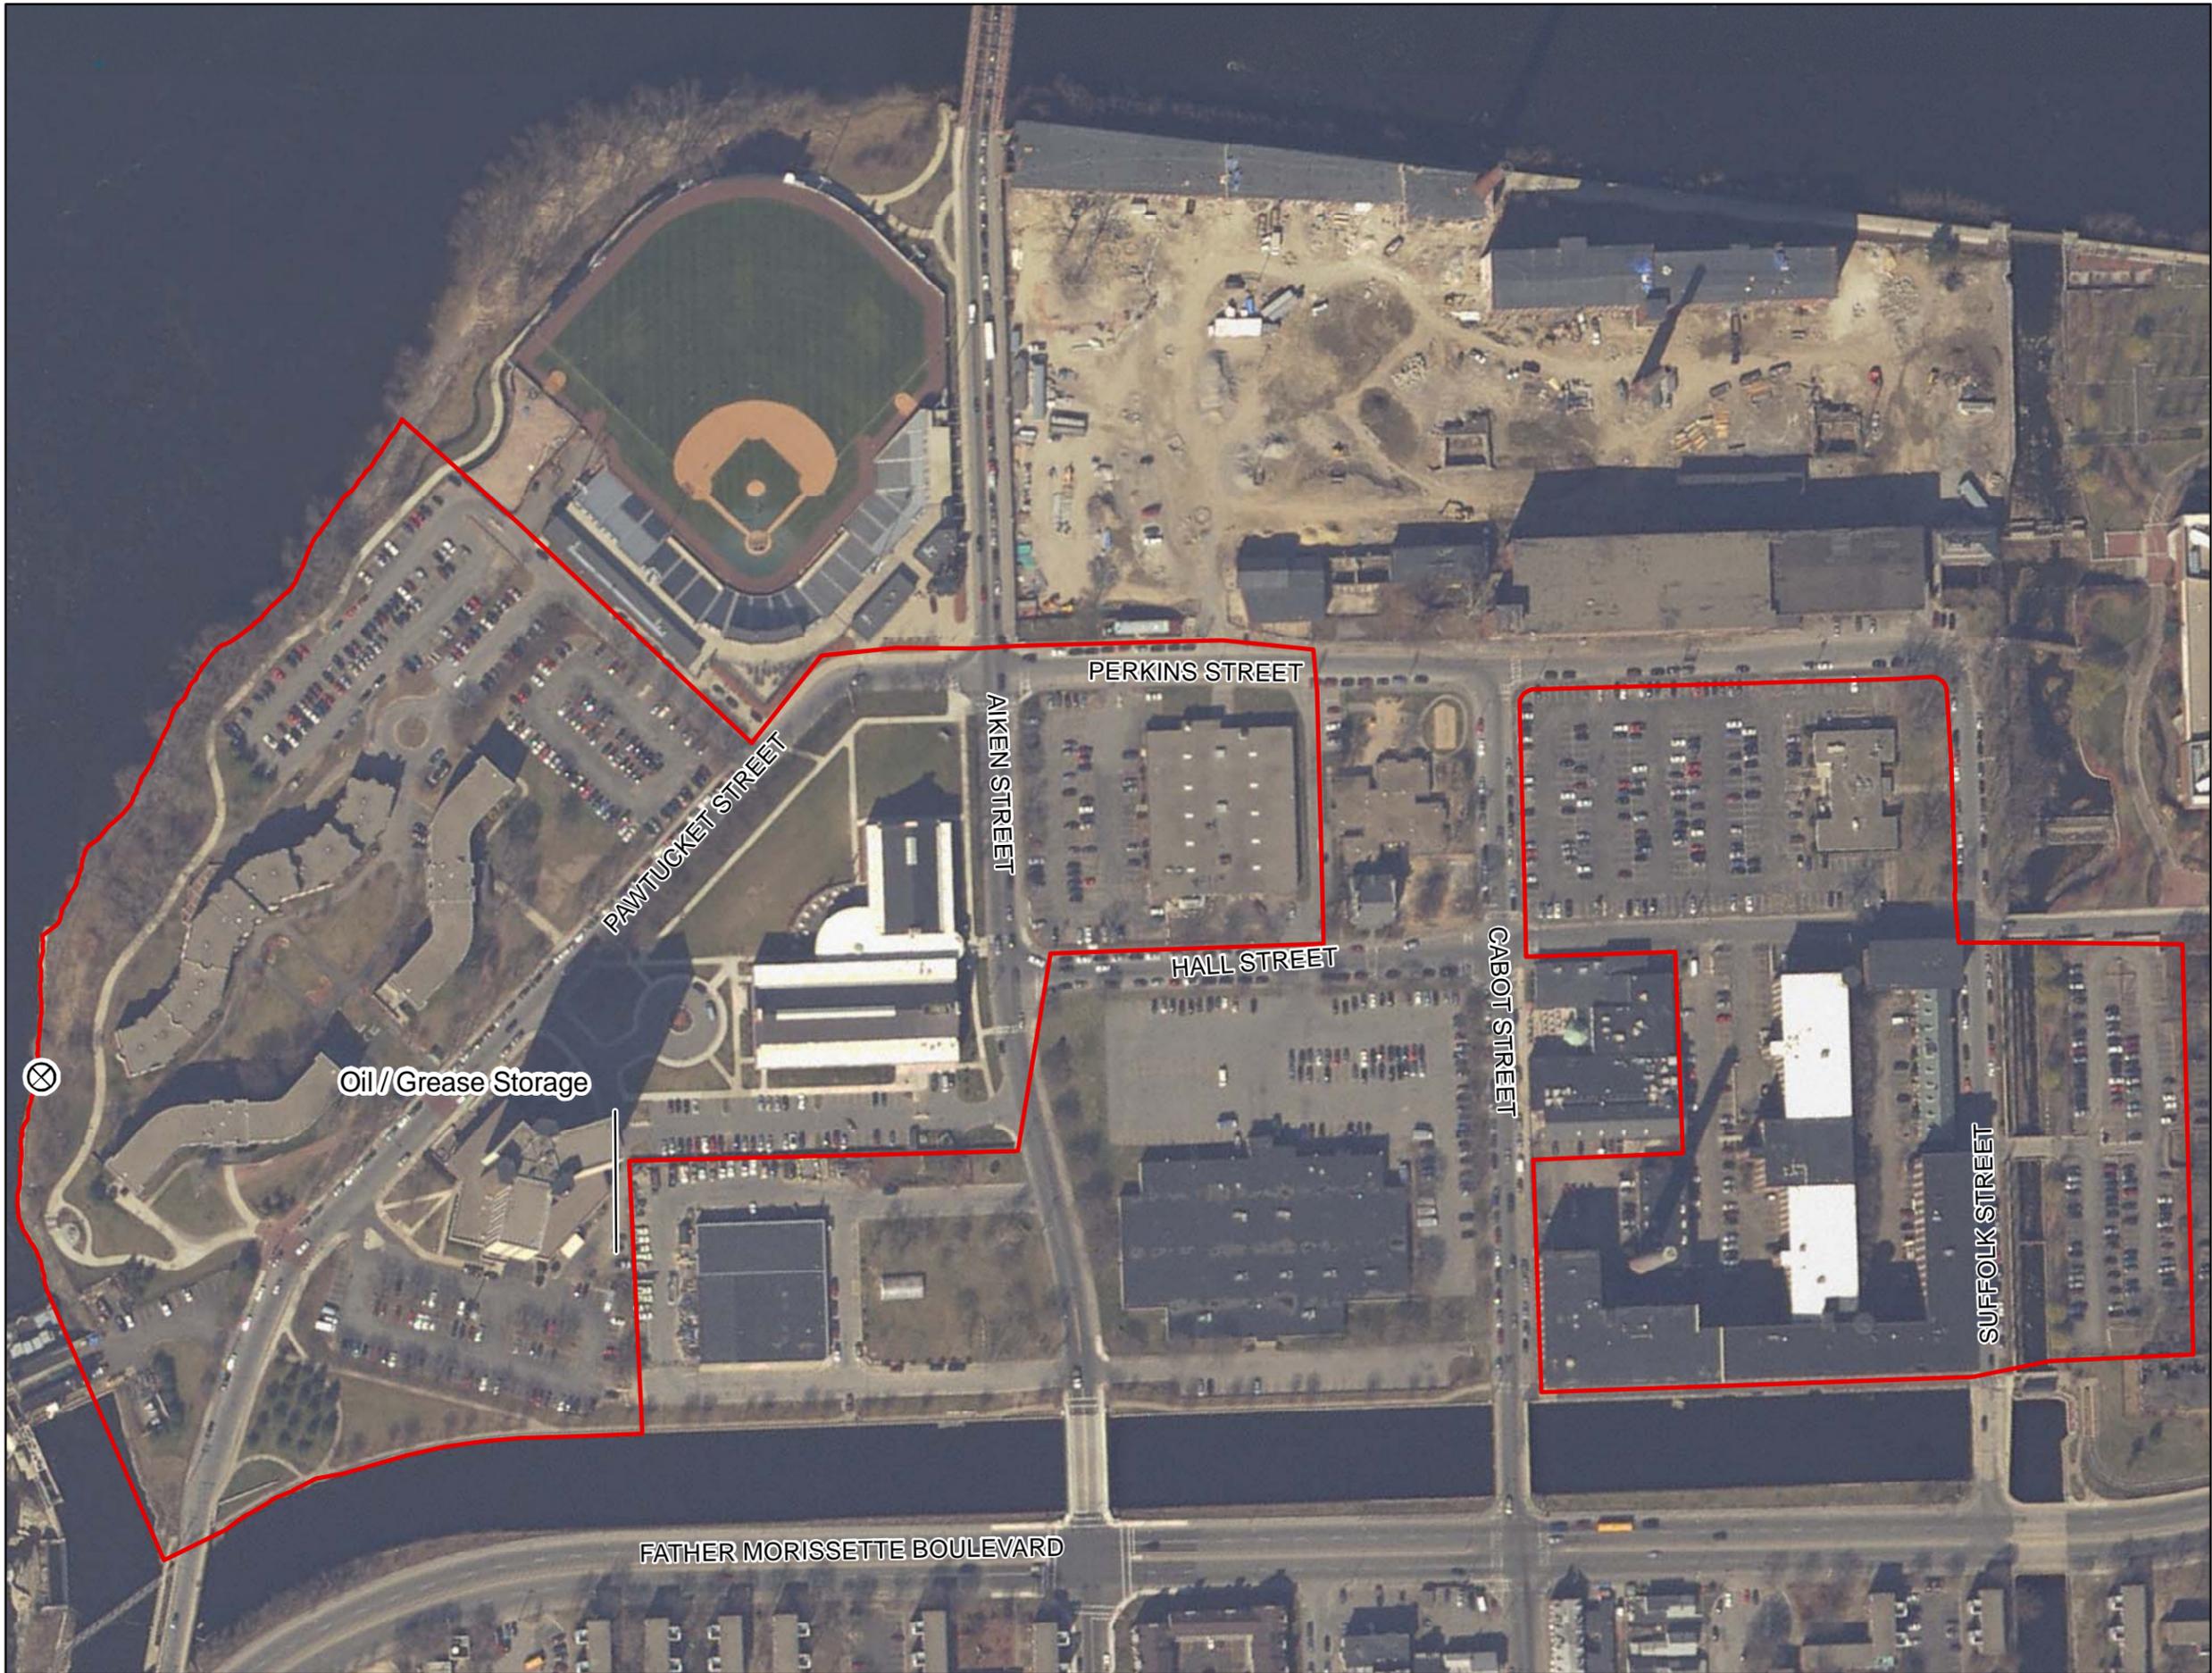
FIGURE 2

Stormwater runoff generated throughout the East Campus is collected via internal roof leaders or catch basins, and conveyed to a stormwater drain or combined sewer. Runoff from the northwestern area of the campus, bordered by Institute for Plastics Innovation to the east, Northern Canal to the south and Merrimack River, discharges to a 42-inch combined sewer on Pawtucket Street. According to the drawings provided by the University, a small portion of the Leitch Hall Roof discharges directly to the Merrimack River through an outfall. One outfall is identified and is shown in Figure 2.

East Campus
 University of Massachusetts
 at Lowell
 Lowell, MA

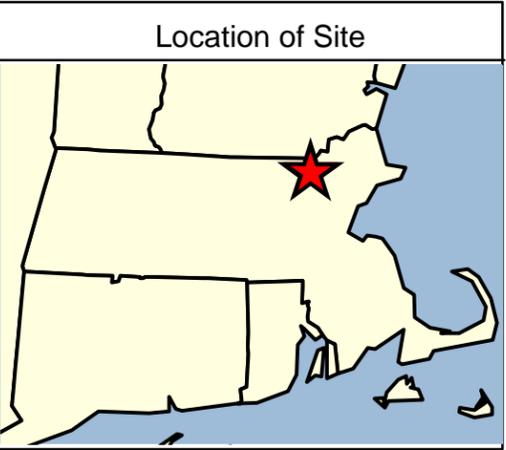
The East Campus is bounded by the Northern Canal to the south and southeast, and by the Merrimack River to the north. Several buildings located within the campus are not owned by the University. The location of the site is shown in Figure 2. The buildings located within the campus include several residence halls, campus recreation center, parking lots, a parking garage, and research centers.

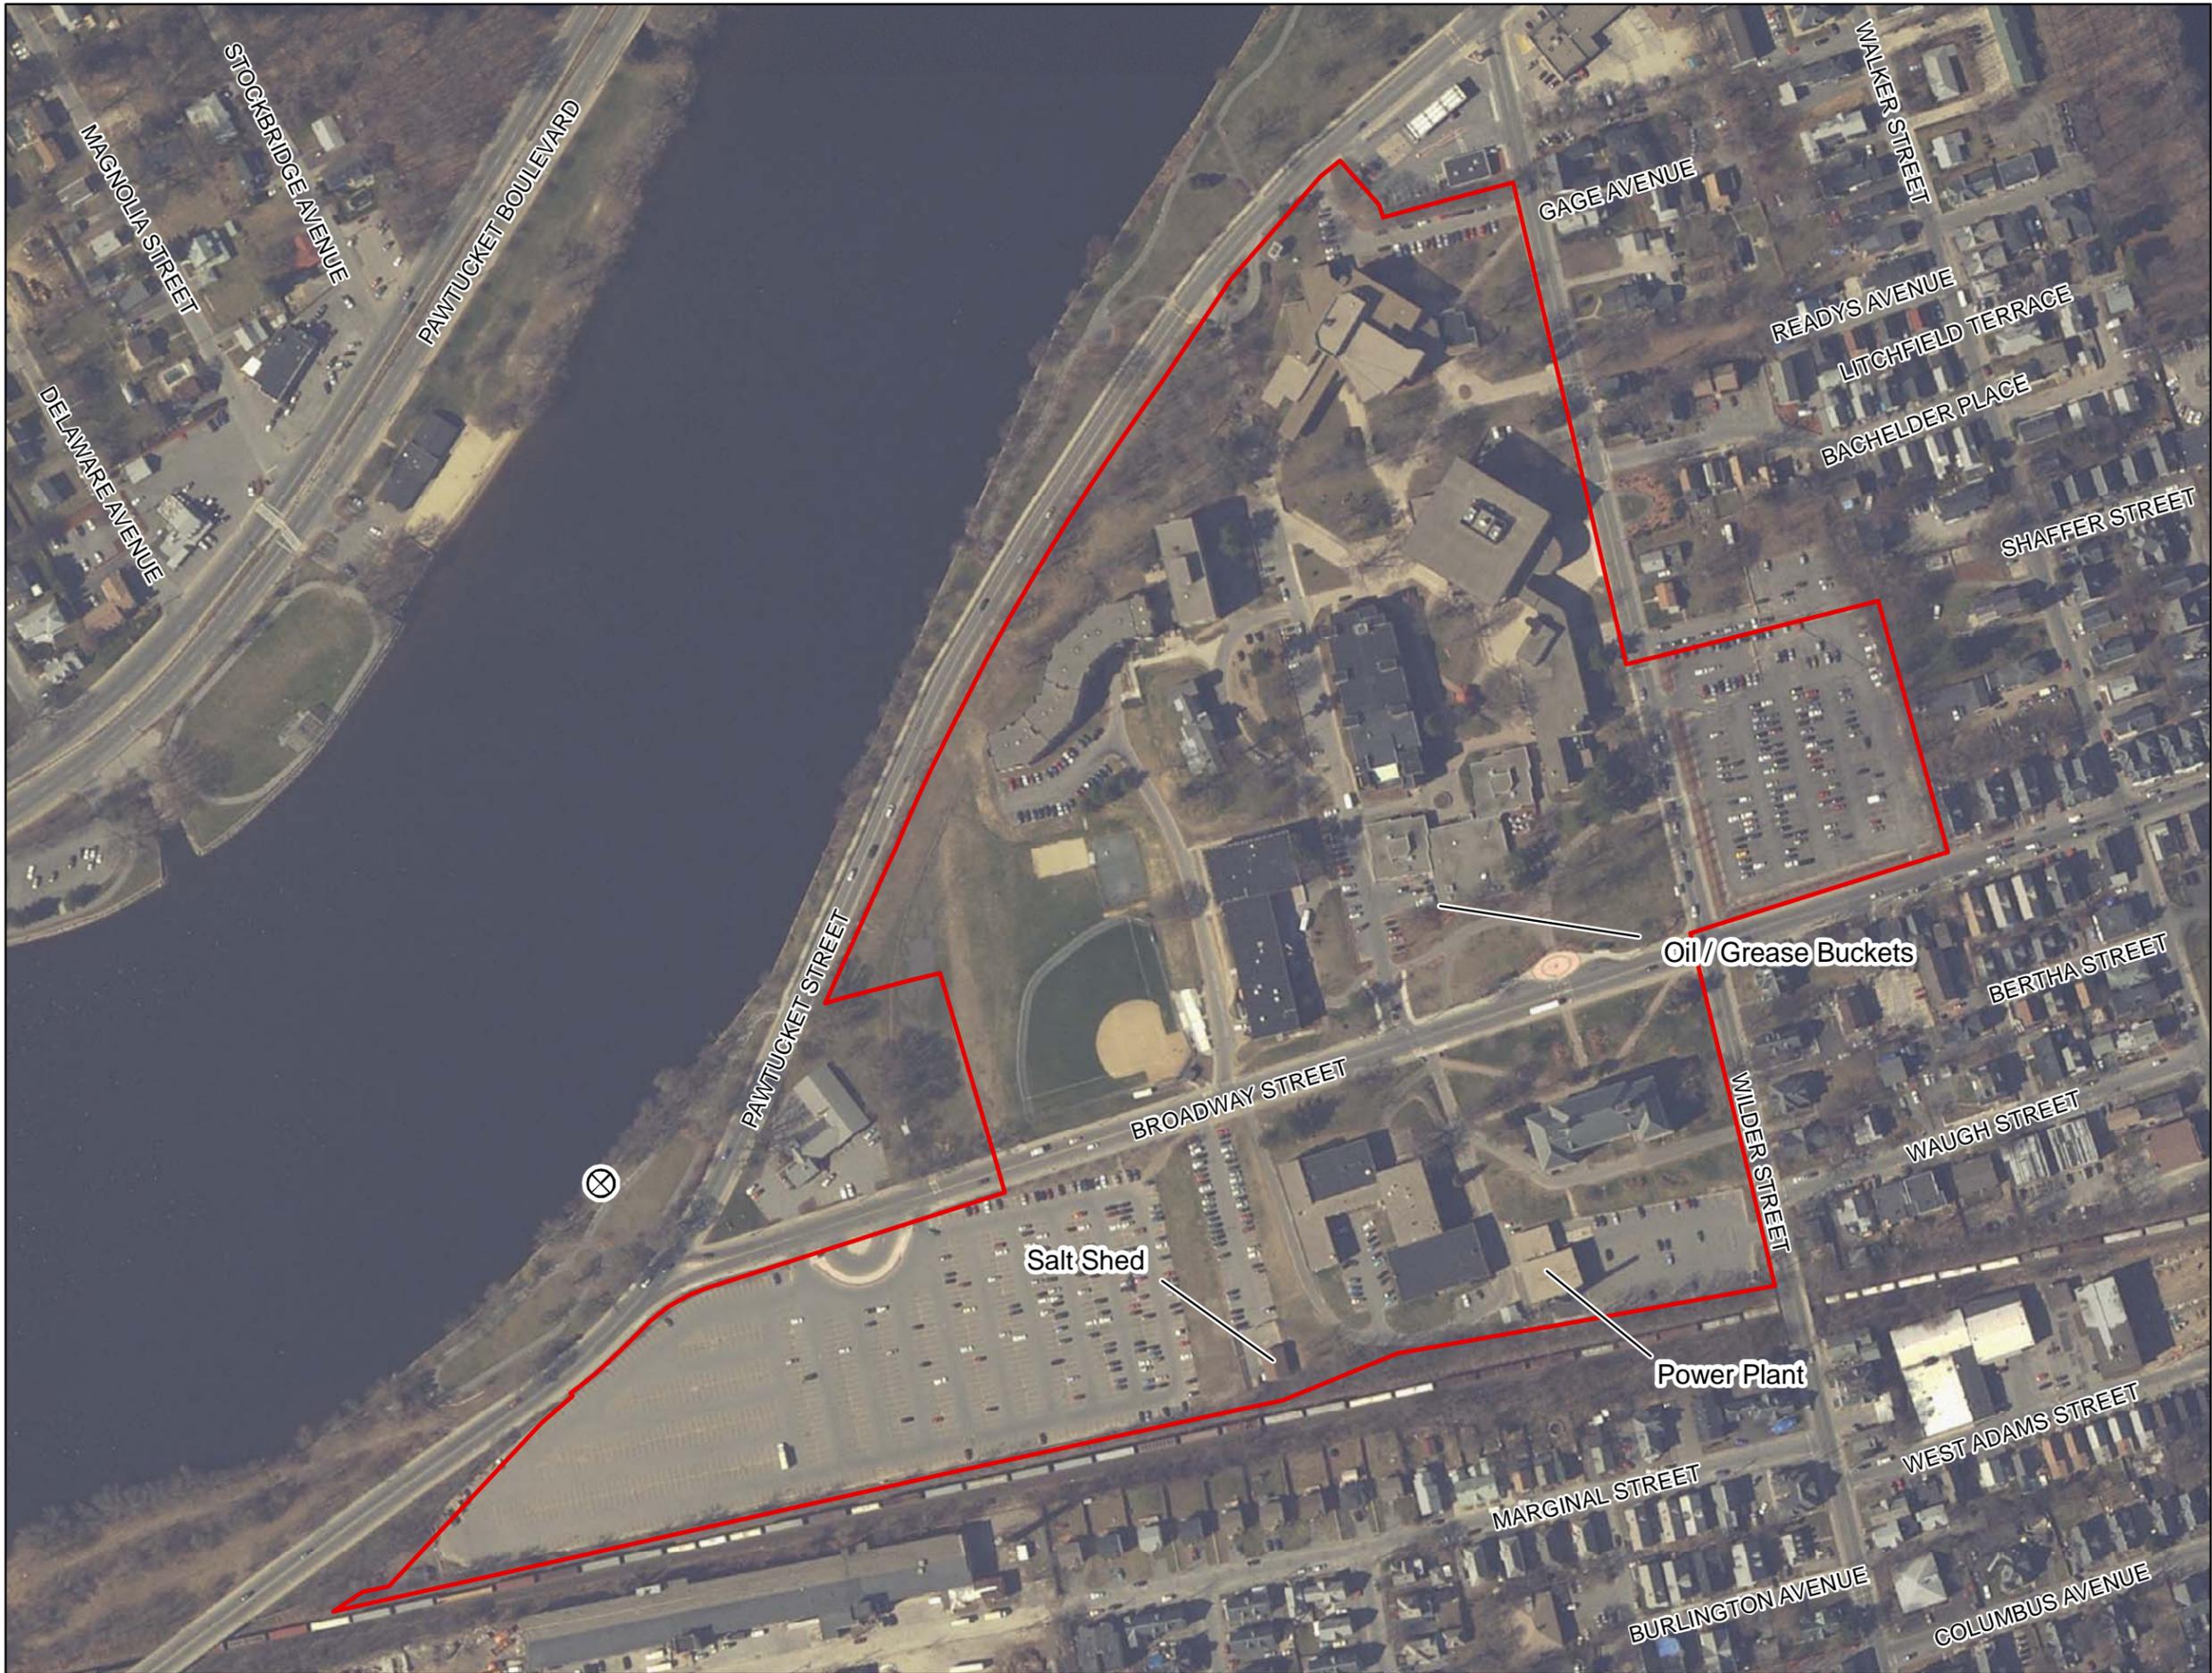
FIGURE 3

Stormwater runoff from the South Campus is collected in several different networks. One network collects runoff from the Dining Hall, Weed Hall, O'Leary Library, and the surrounding areas. This storm drain ties into a 27-inch municipal storm drain on Wilder Street. Stormwater runoff from the area north of O'Leary Library is collected via catch basins and conveyed to the 27-inch municipal storm drain on Wilder Street. Another network collects runoff from Sheehy Hall, Concordia Hall, and an adjacent parking lot. An 18-inch storm drain leaves the University property. This drain either discharges directly into the Merrimack River or municipal storm drain on Pawtucket Street. Stormwater runoff from Durgin Hall and the area north of the building is conveyed through a 12-inch pipe; according to a records review, the 12-inch pipe is connected to the municipal storm sewer located on Pawtucket Street. Dugan Hall and the surrounding areas are tied to a combined sewer connected to the municipal sewer on Broadway Street. Riverview Parking Lot has a separate storm drain system, which discharges directly into the Merrimack River through an outfall. Stormwater runoff from Coburn Hall and the Power Plant is conveyed to the combined sewer on Wilder Street. One outfall is identified and is shown in Figure 3.

South Campus
 University of Massachusetts
 at Lowell
 Lowell, MA

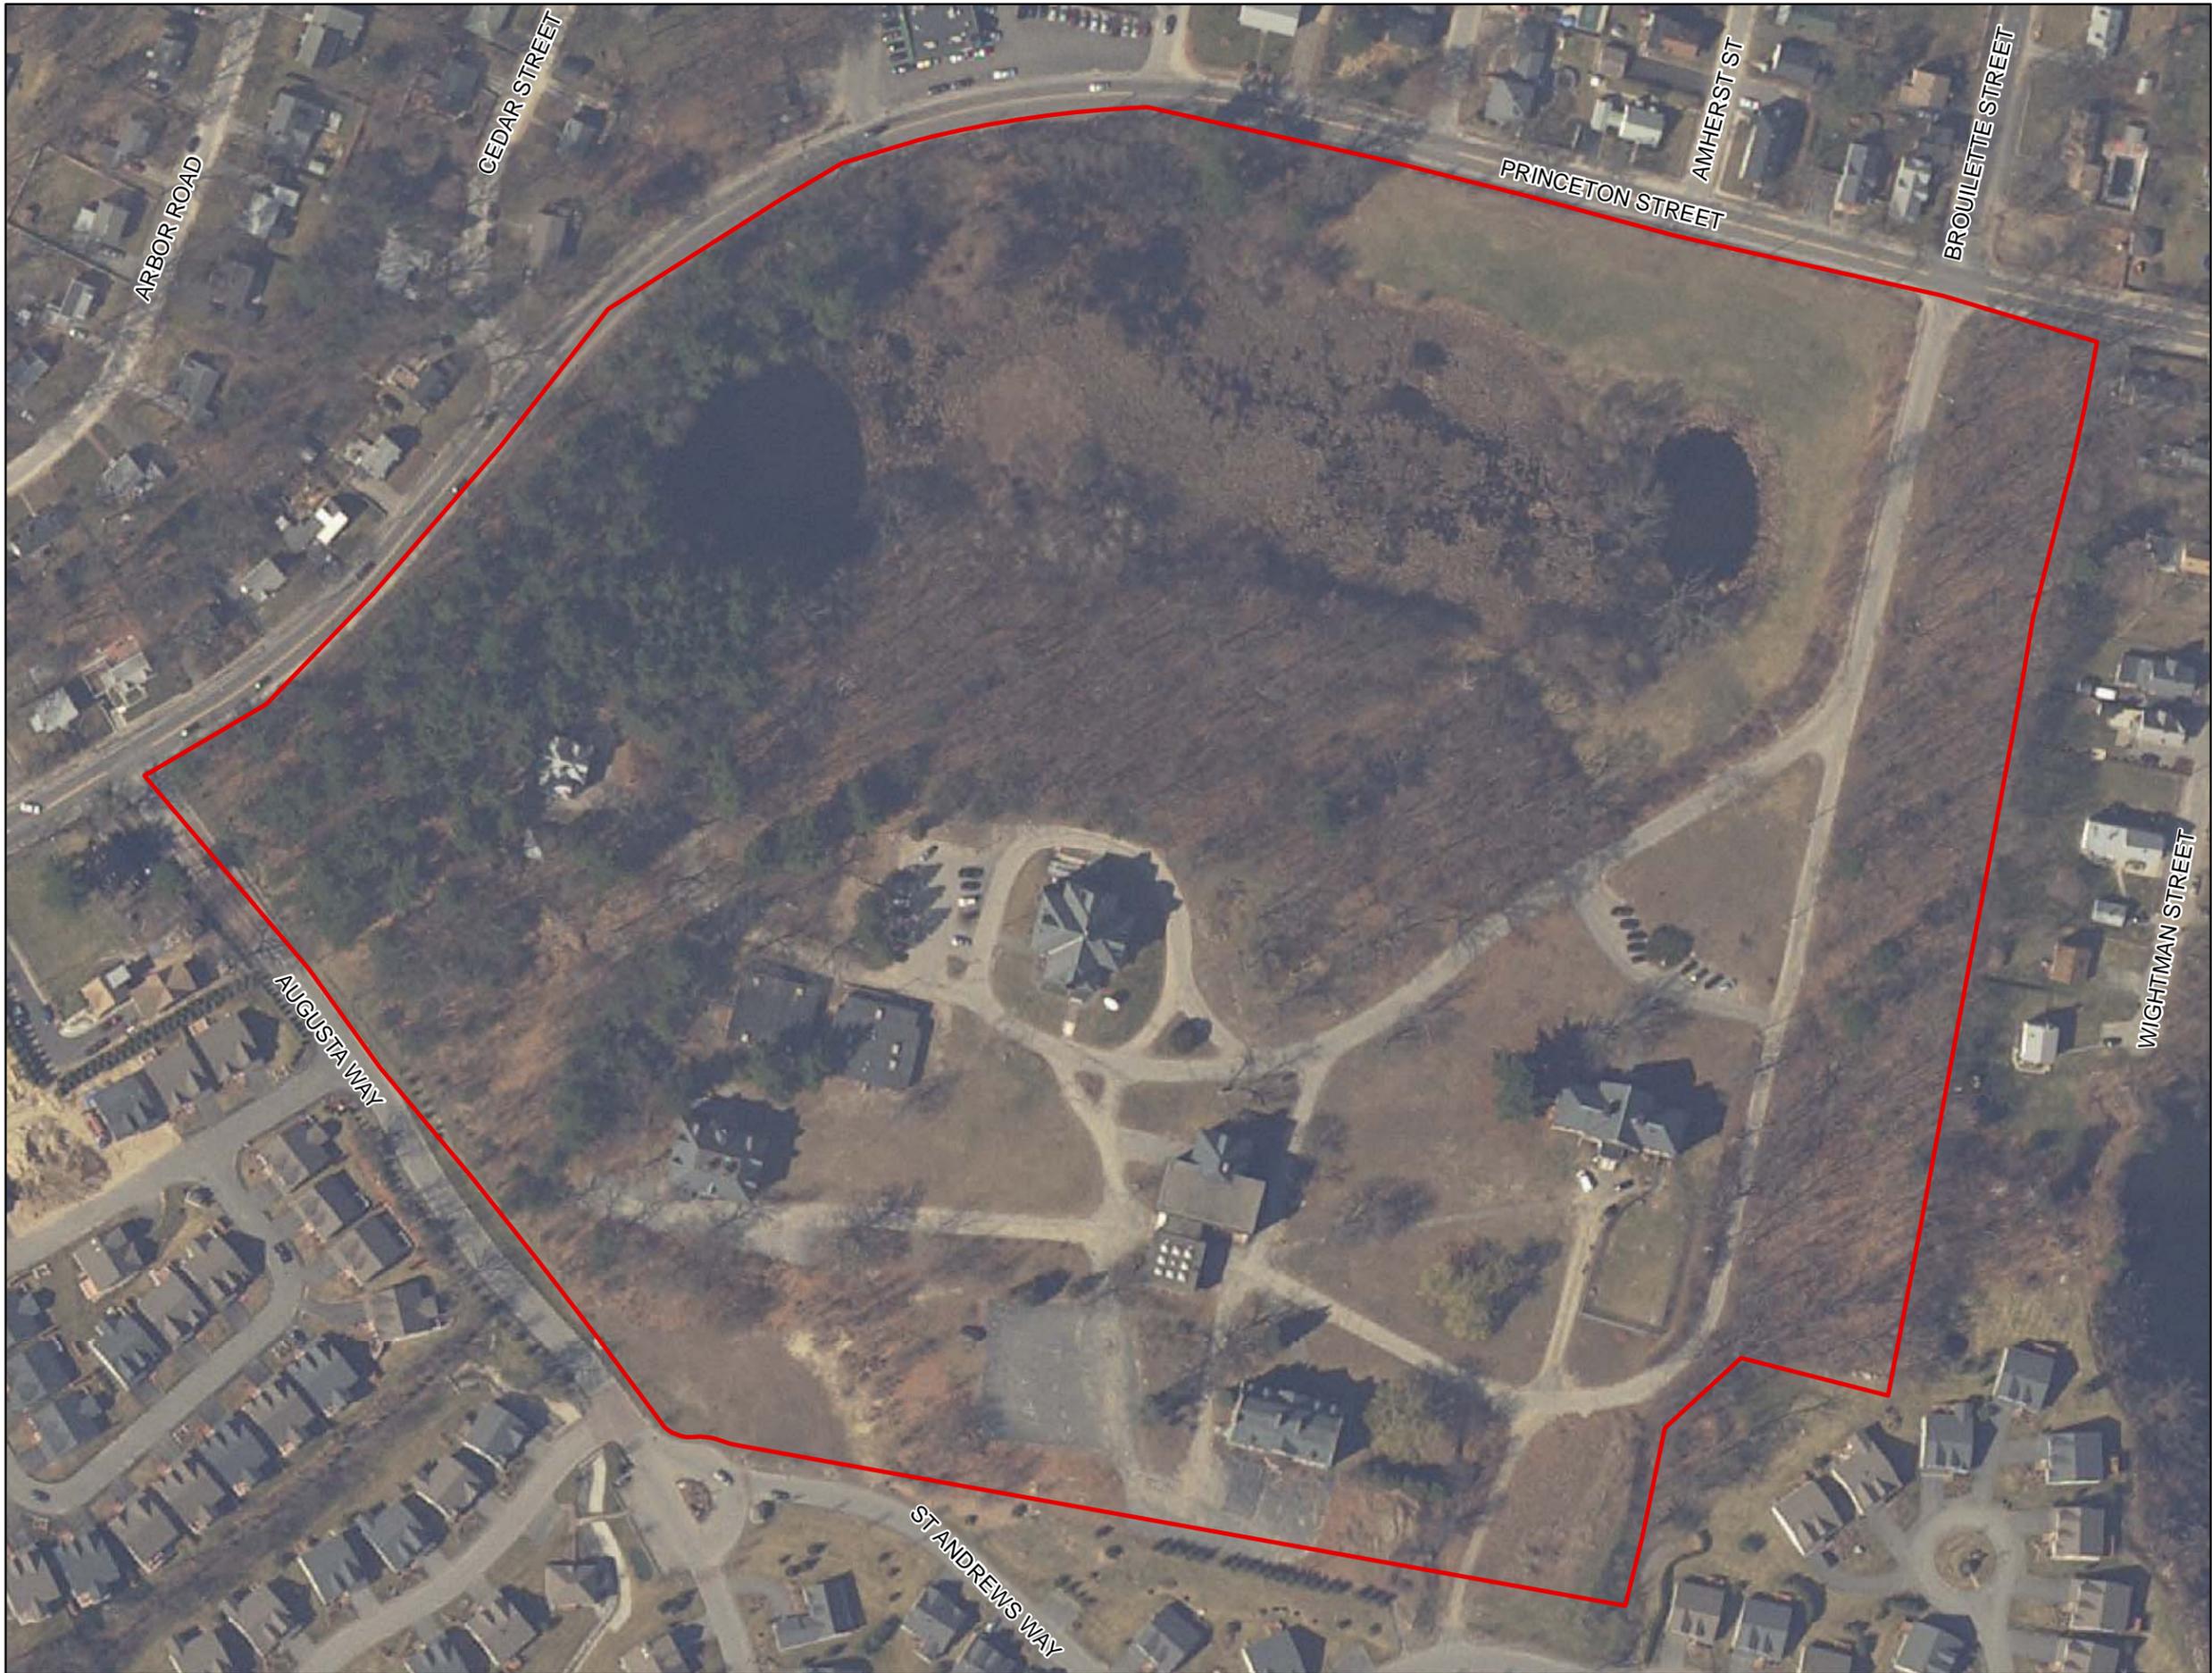
FIGURE 4

Stormwater runoff from the southern portion of the site appears to be collected via catch basins and conveyed to a stormwater drain. According to the drawings provided by the University, the stormwater drain connects to the municipal storm drain on Princeton Street. Additional catch basins located on the paved roadway, between Bigelow Building and Richardson Hall, appear to be isolated and not connected to any drainage system. Stormwater runoff from the roofs is collected via downspouts and infiltrated into the ground. West Campus is represented on Figure 4.

West Campus
 University of Massachusetts
 at Lowell
 Lowell, MA
