## APPENDIX E - Digital Image Correlation Effort

### Executive Summary:

Digital Image Correlation (DIC) were made on three separate TPI Composites CX-100, 9 m wind turbine blades (Sandia “Sensor Blade”, LANL Blade and UMass Lowell Defect Blade). The results of the tests on the Sandia blade revealed that DIC could readily identify changes in strain and surface geometry due to cracks present in the blade after being subjected to fatigue failure. The Sandia blade tests also revealed that multiple images can be stitched together to obtain the blade geometry, deformation, and full-field strain over the entire blade area. The LANL blade served as a baseline (defect-free blade) for comparison in which DIC was used to interrogate the same six areas that possessed defects in the UMass Lowell blade. The results revealed that there was no significant increase in strain at these locations in the defect-free blade. DIC was also used to interrogate the six different locations that possessed defects in the UMass Lowell blade. The results indicate that DIC can be used as a full-field inspection technique to identify defects (via strain amplification) and monitor the progression of crack growth o

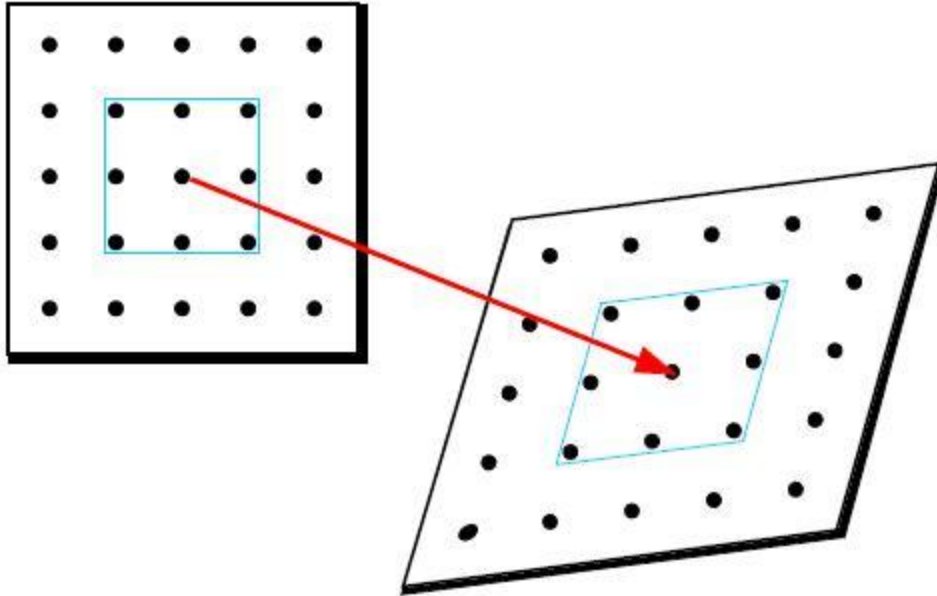
Figure E.4 Strain computation from 3D points (5).

The strain for each 3D point on the measured surface is calculated by measuring the deformation of an array of surrounding points from stage to stage, as shown in Figure E.4. As the array of 3D points deform, the displacement from the original length is calculated for the two-dimensional plane tangential to the measurement surface. Using the finite-strain equations described earlier, the linear strains in each x and y directions are calculated, as well as the shear angle.

The total deformation of this set of 3D points relative to the defined reference stage defines the amount of strain computed at that center point. The size of surrounding array of points is known as the **computation size** of the project, and essentially establishes the strain-gage length for the project as the linear strains are calculated over this computation size, see blue box (computation size of three) in Figure E.4. The noise floor of the measurement is directly related to the computation size of the project, and the sensitivity to the amount of strain which can be measured decreases as the computation size increases. A **validity quote** is established in the cases where the entire array of surrounding points might not be available, such as on the edge of a surface. This parameter is defined as the percentage of surrounding points that are used in the strain calculation. If the number of 3D points surrounding the point of interest is below this parameter, then the strain will not be calculated for that point. The ARAMIS™ default values are set to a computation size of three and a validity quote of 55% of surrounding points.

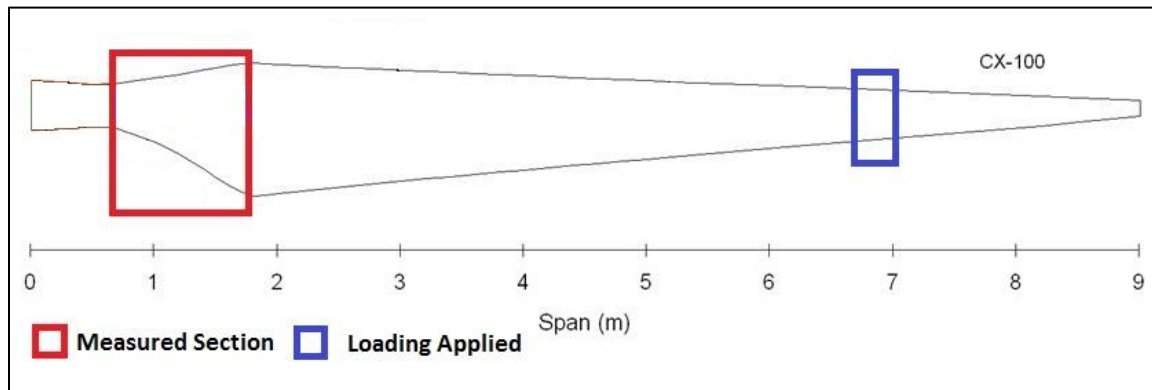
Figure E.5 Planform view of the CX-100 wind turbine blade, indicating the DIC measurement and loading locations.

During the fatigue test, two damage areas were observed and tracked as the damage developed throughout the testing. Damage areas include along the trailing edge of the blade and on the low-pressure skin at approximately 1 meter span from the root of the blade. Both damage areas were between the root and maximum chord of the blade, with the span location represented by the large red box as shown in Figure E.5. The DIC measurements of full-field displacement and strain were performed on this area. The smaller blue box located at a span of approximately 6.75 meters (as shown in Figure E.5) indicates the area of the static loading applied during the testing.

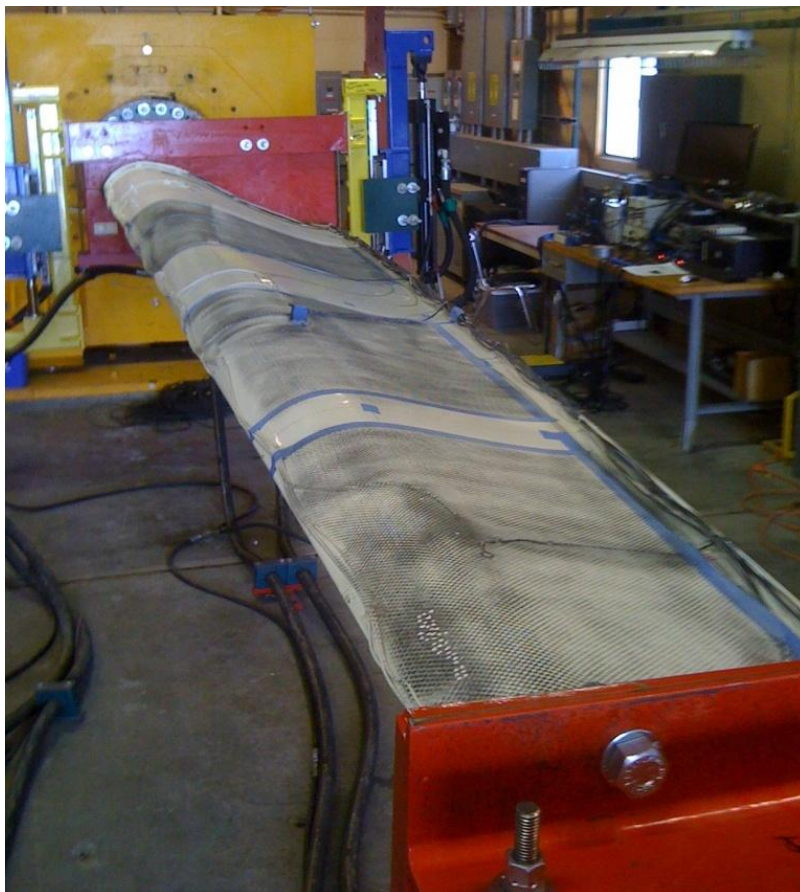
Figure E.7 LANL defect free blade with DIC patterning.

Figure E.7 shows the LANL blade with required locations prepared for DIC measurement. As shown in Figure E.7 saddles were mounted to the blade. These saddles were to provide the required excitation for the scheduled fatigue test.

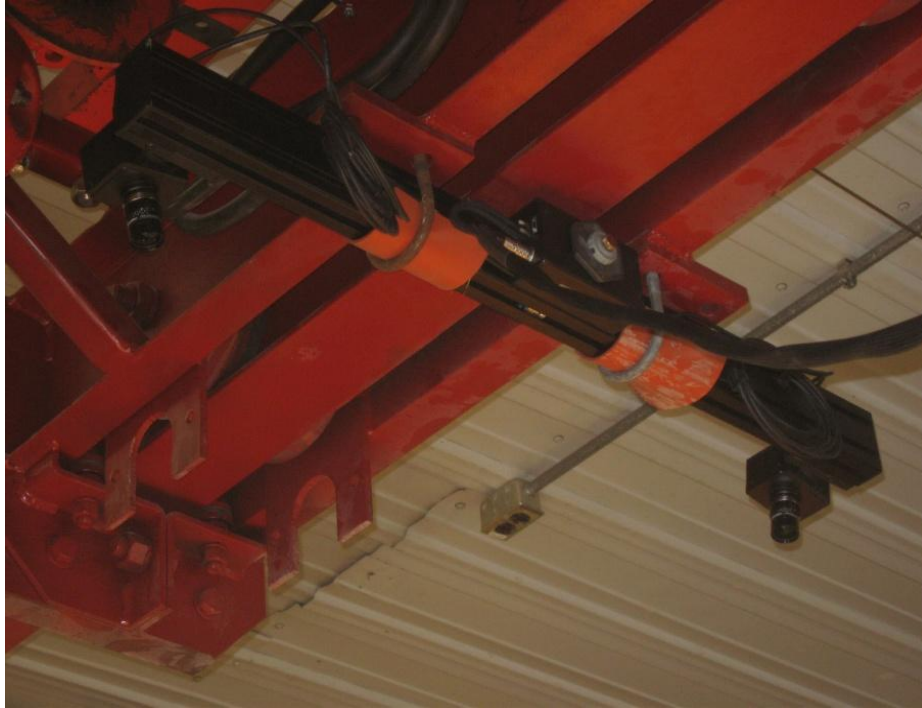
Figure E.8 Camera bar mounted to overhead gantry.

The 3D DIC system cameras were first calibrated for a 1 meter field of view, and then mounted to an overhead gantry as shown in Figure E.8. Once mounted to this gantry, three 1000 watt spotlights were used to light the required field of view. A large dead weight of 520 lb was hung from the outboard saddle at a span position of 6.75 meters as shown in Figure E.9. A series of five image stages were taken, at a rate of 12 Hz, in both unloaded and loaded states. This test methodology was repeated for each measurement location.

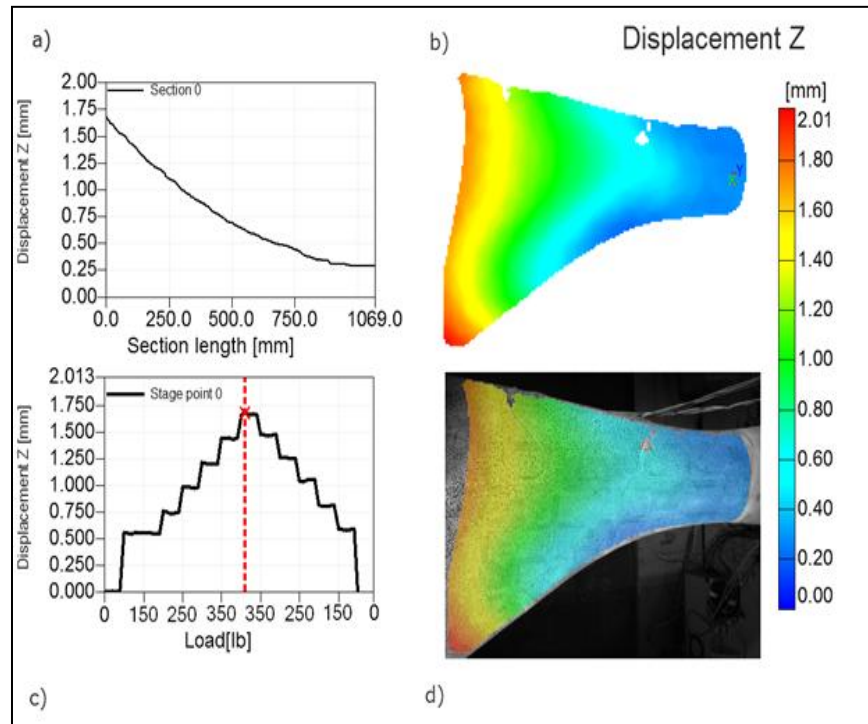
Figure E.10 Measurement displaying curvature of blade along the HPS at a 400-lb load level (a) displacement section line along the length of the blade (root shown on right); (b) spatial displacement contour near the blade root; (c) displacement along the left side

Measurements were first made on the HPS of the CX-100 blade surface. The full-field curvature of the blade as a function of both load and section length is shown in Figure E.10. The processed data is used to show the displacement and curvature of the blade as a function of the

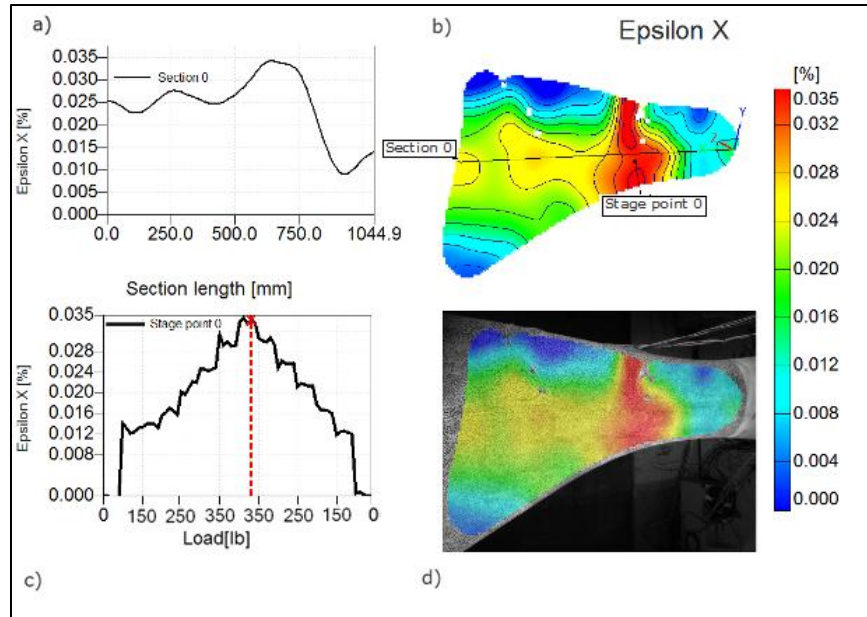
Figure E.11 Measurement displaying strain of blade along HPS at a 400-lb load level (a) strain along section line lengthwise of blade (root shown on right); (b) spatial strain contour near blade root; (c) strain at point 0 (shown in (b)) as a function of applied load

various loading levels. To gain further insight into how the blade was affected by the previously conducted fatigue testing, the full-field strain contour over the blade surface was analyzed. The results are shown in Figure E.11. There is a localized high level of strain at approximately 700 mm from the left portion of the image. This result indicates that something is causing this strain amplification in the observed section of the blade.

The span-wise strain overlaid on the CX-100 surface for the same loading situation is shown in Figure E.19. Span-wise strain as a function of span location is shown in Figure E.20. Areas of measurement dropout in Figure E.19 are due to other instrumentation covering the blade surface. Therefore an accurate measurement could not be made in these areas. Several observations that can be made from the strain distribution on the HP surface of the blade is the concentration of high strain areas toward the leading edge of the blade on the spar cap. This is to be expected as the shear web, which bridges the HP and LP surfaces of the blade, mounts to this spar cap. The area of highest strain due to the loading scenario, also observable in Figure E.20, is located just past the 5 meter location. Also, notice the area close to the root of the blade also contains an area of high strain, which was witnessed in the close up testing of the preliminary blade and showed in detail Figure E.11.

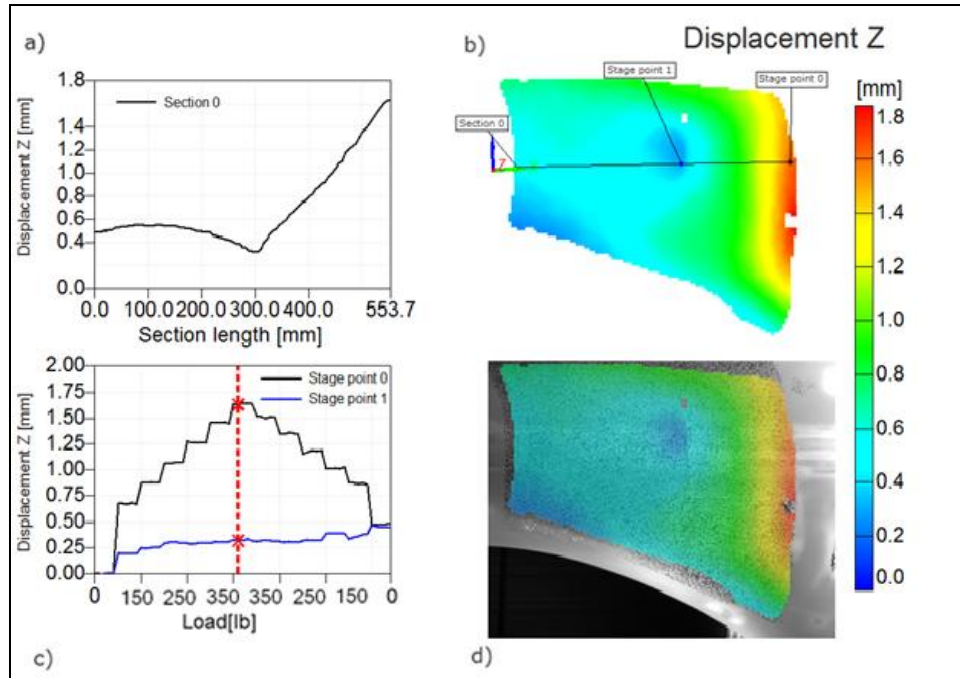
When the LPS of the blade was tested in the same manner, a discontinuity in curvature was observed, as shown in Figure E.12(a). A visual inspection identified a large crack in the blade at the location of the measured discontinuity. The corresponding displacement contours shown in Figure E.12(b) and Figure E.12(d) also reveal a spatial displacement discontinuity in the blade. When the displacement at locations on opposite sides of the crack are compared, the displacement at the location near the blade root (point 1) no longer is being loaded in the same manner as the displacement locations between the crack and the applied load (see Figure E.12(c)). This loading difference implies that the load path has been changed due to the presence of the crack. The presence of the crack or damage location is even more revealing when the strain field is observed, as shown in Figure E.13.

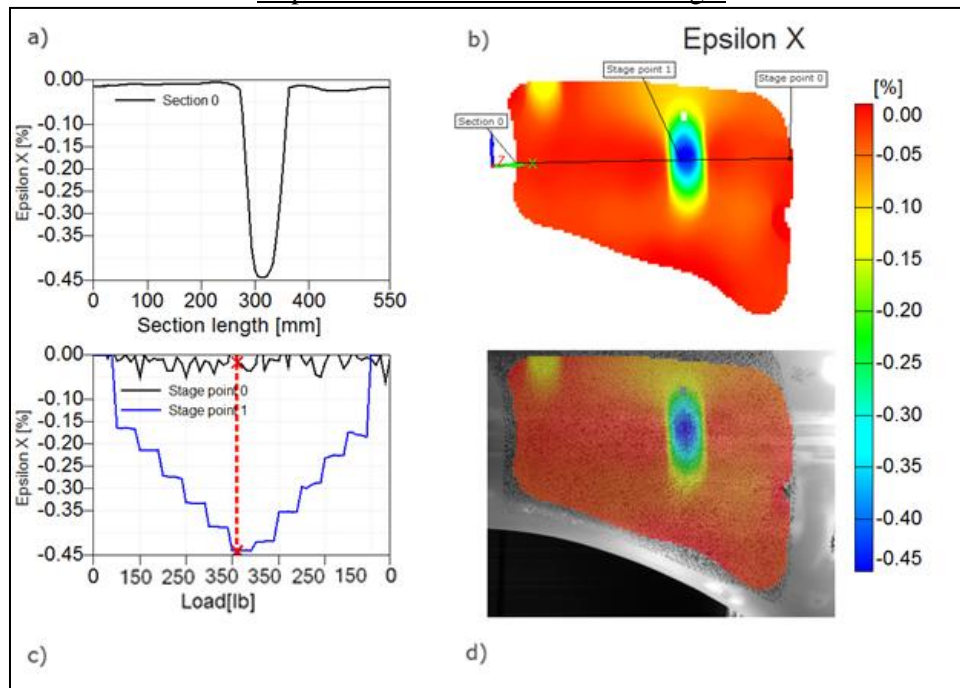
The section line of Figure E.13(a) shows an amplification of strain in the location of the damaged area. The contour shown in Figure E.13(b) indicates that there is a crack or “damage” causing a locally high strain in the area. This crack is approximately co-located on the opposite surface of the high strain witnessed in the HPS test. The strain is negative in the LPS tests due to a compressive load, whereas the positive strain in the HPS test is due to the tensile load on the high-pressure skin of the turbine blade during these tests.

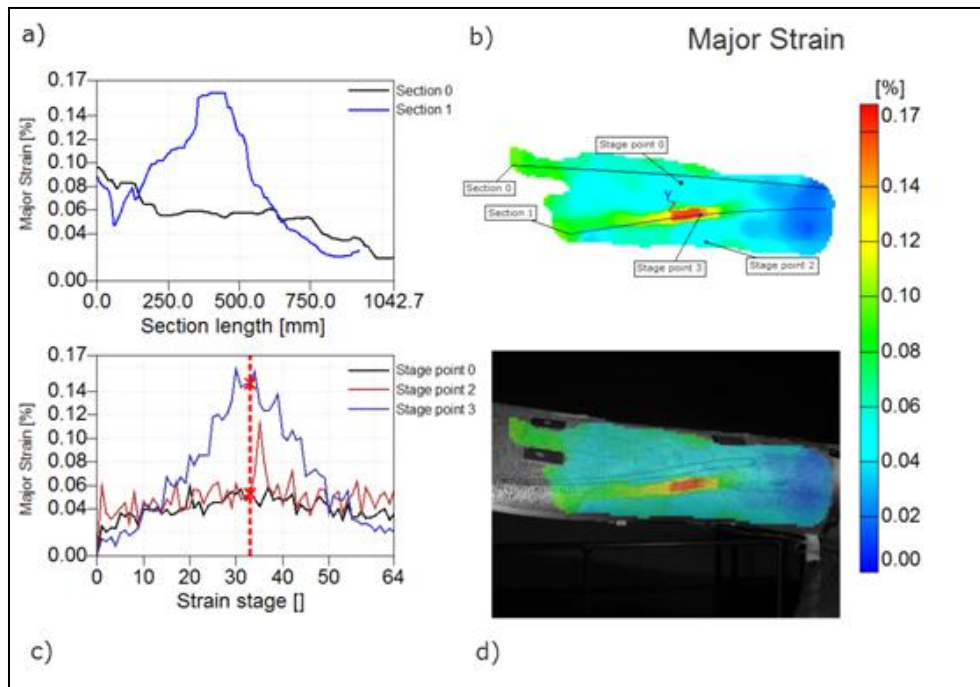
During the fatigue loading of the blade a second significant damage area along the trailing edge of the blade was observed. The same stepped loading cycle as previously described was applied when measuring this portion of the blade. The strain results for the trailing edge are shown in Figure E.144.

Major strain is defined as the maximum principle strain occurring at each measurement point on the surface, and therefore is always positive. The major strain contour shown in Figure E.14(d) clearly shows an amplification of strain in the location of a damage area which initiated and propagated during the fatigue testing.

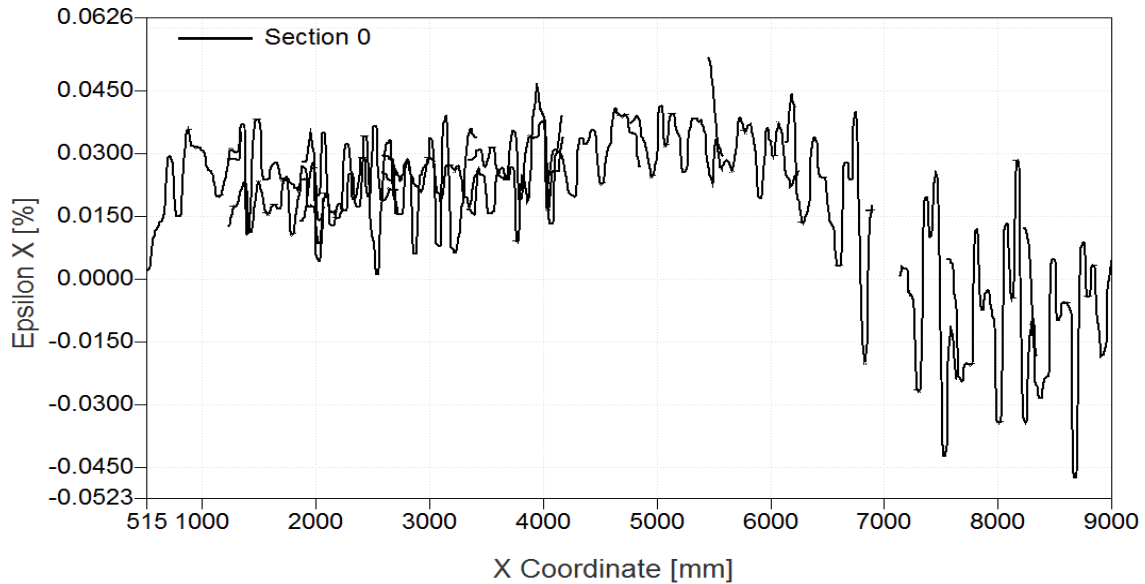
Figure E.20 Span wise strain along the centerline across the length of the blade for an applied load of 350 lb.

The strain displayed in Figure E.20 shows overlapping curves. Each line represents an individual section, i.e. a measured field of view. There are 16 separate curves, each approximately a one-meter section along the length of the blade. The separate curves show the overlapping sections. Each section's strain is filtered within its own field of view. Therefore when overlapped with the next strain surface, the filtering is slightly different, which results in small deviations of strain measurement. The same is true for the displacement graph, shown in Figure E.18. However the noise on the displacement measurement is smaller than the actual width of the curves, so the curves appear as a single trace.

The strain measured throughout the full length of the blade shows the highest strain due to the applied load at approximately the 5 meter span location. The strain measured in the prior stepped loading tests showed a spike in strain at approximately the .75 meter span location. The result is also visible in Figure E.19. However the strain measured at the 5 meter location, in the area of the spar cap, is greatest.

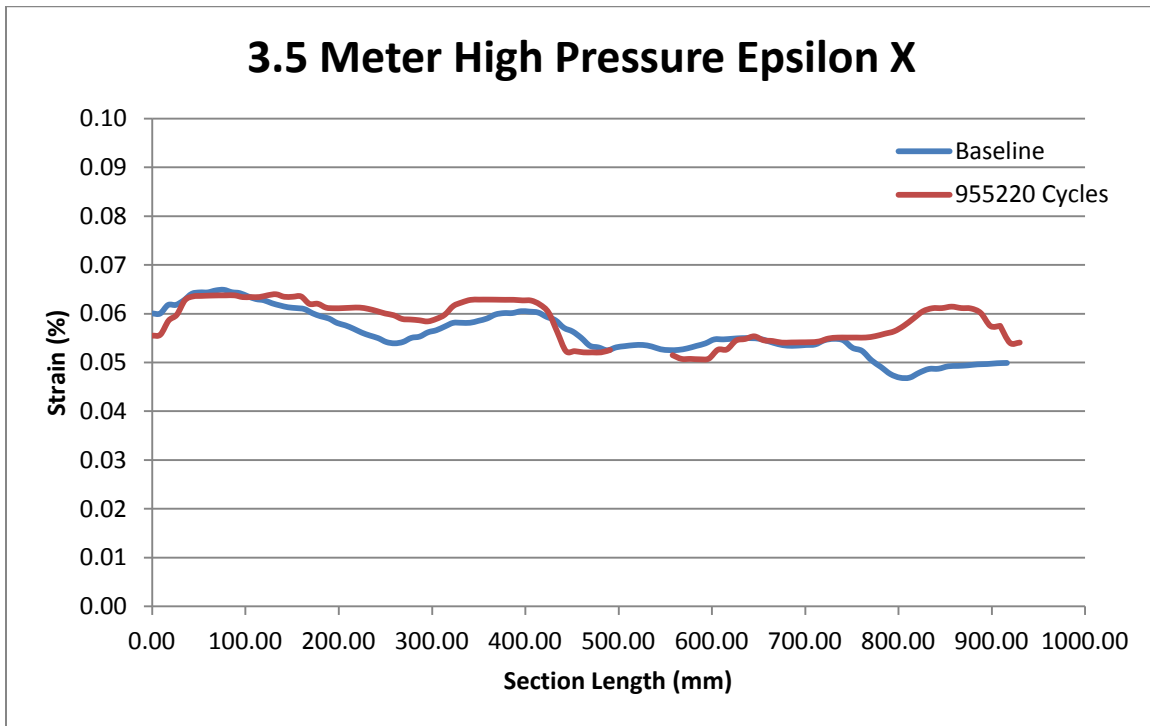
Figure E.24 Strain comparison between baseline and 955,220 cycles at 3.5 meter location.

A comparison, between baseline and after 955,220 cycles, of the strain and displacement over “Section 0”, defined in Figure E.23, is shown in Figure E.24 and Figure E.25, respectively.

The measured strain in Figure E.24 shows the small differences between the two tests. The strain is slightly higher along the section length after the ~955,000 cycles are applied although there are no significant changes in the blade surface characteristics. The displacement shown in Figure E.25 shows slightly more displacement (0.59mm), after the cycling than that of the baseline measurement at the 3.5 meter location. However the curvature remains fairly constant. The results at the 5 meter location, shown in Figure E.26 through Figure E.29, appear to be similar. Any dropouts in data are due to other sensors installed in the area, along with cabling, which prevented measurement on the surface of the blade.

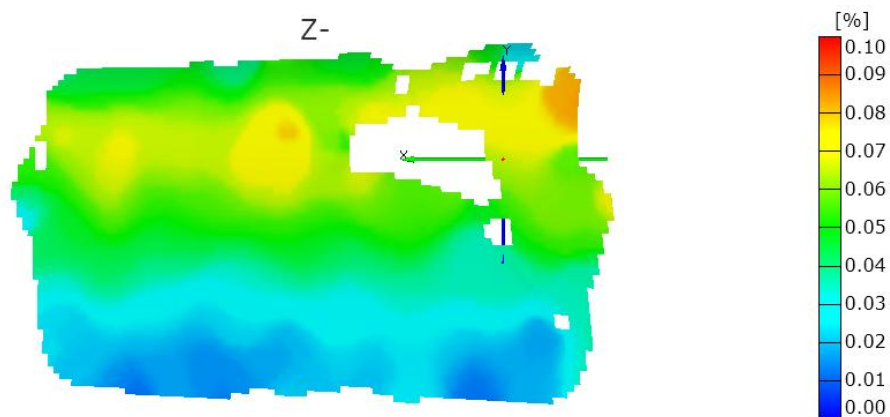
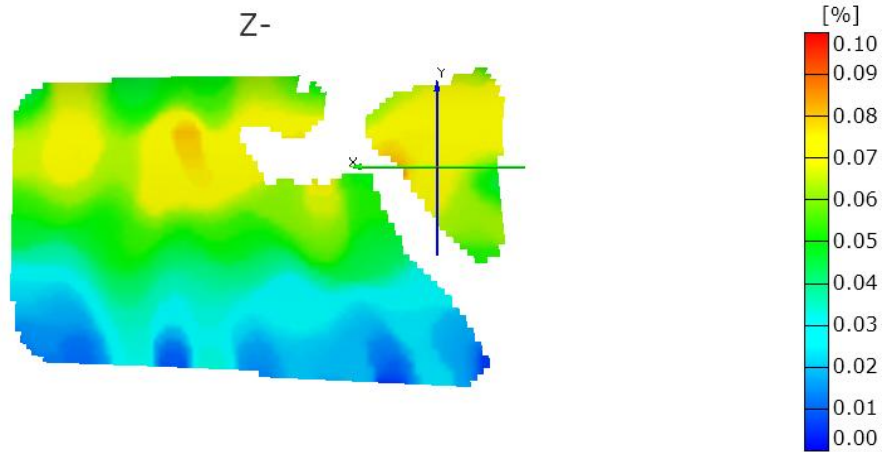
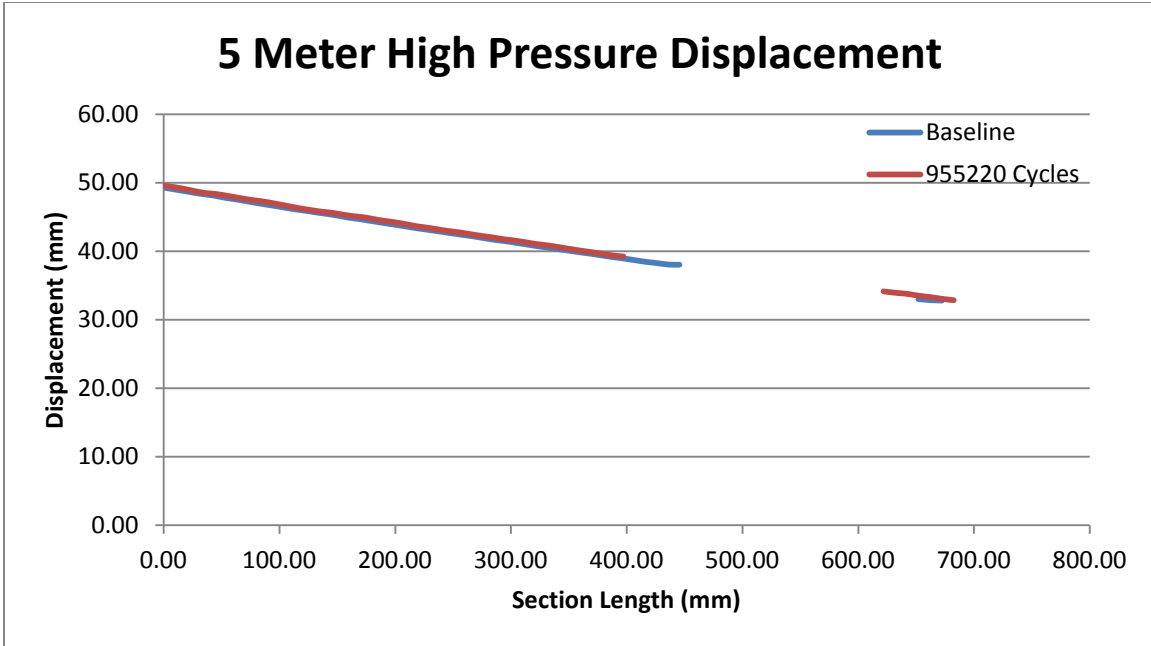
The data from the 5 meter section of the blade exhibits similar behavior at 955,220 cycles as at the baseline. The strain field is slightly more erratic with higher amplitude peaks at 955,220 cycles, although the curvature of the blade remained constant after the fatigue loading cycles. The data collected for the 6 meter section, shown in Figure E.30 through Figure E.33, is consistent with the other measured sections.
