**BLADE FATIGUE TEST REPORT
REV-120927**

**LABORATORY FATIGUE TESTING OF THE 9-METER UML DEFECT
WIND TURBINE BLADE**

National Renewable Energy Laboratory
National Wind Technology Center
1617 Cole Blvd
Golden, CO 80401

27 SEPTEMBER 2012

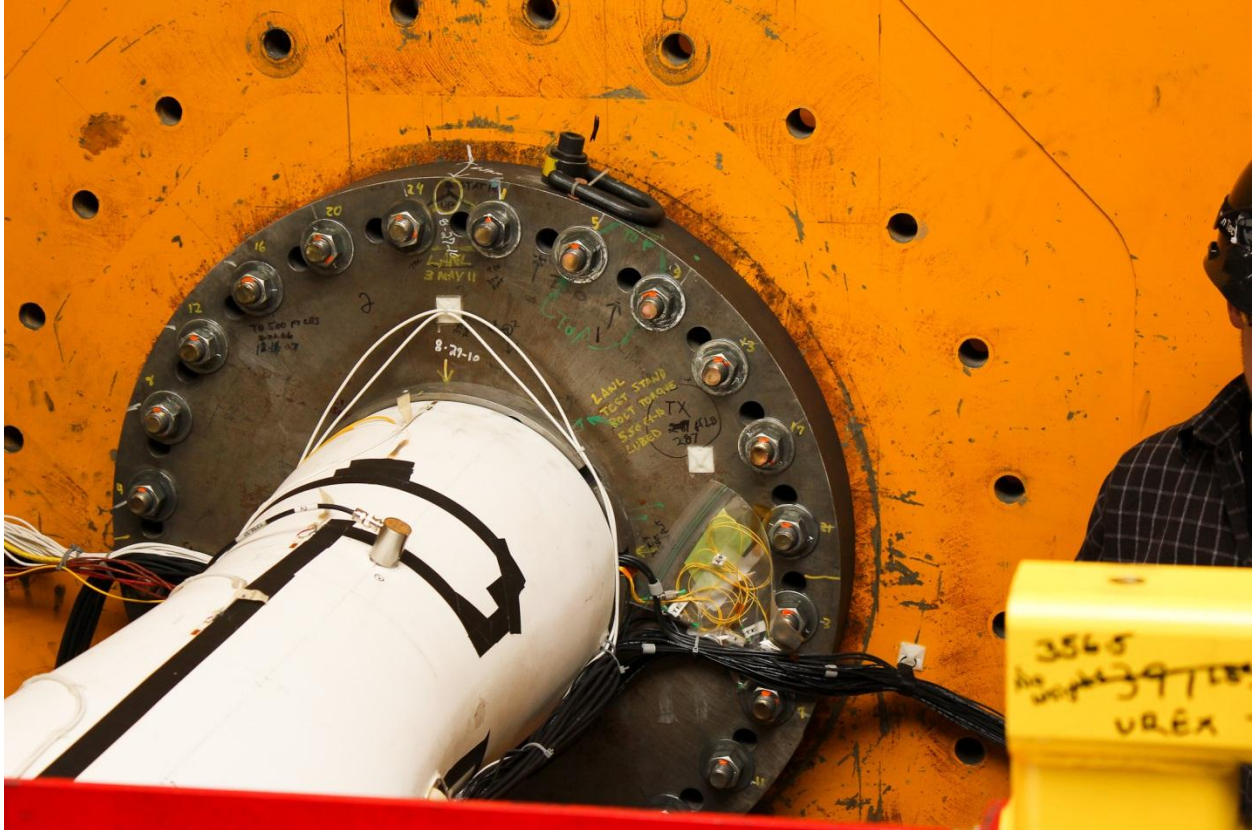
Figure 5.1 – Root Fixtures

A 4-in (10.16-cm) thick steel adapter plate was used to interface the test stand bolt circle and the blade root bolt circle. The adapter plate was secured to the test stand using quantity 24 UNC 1-8, 9-in (22.86-cm) length, Grade 8 steel fasteners on a 30-in (76.2-cm) bolt circle that were torqued to 550-ft-lbs (746-N-m) and lubricated with TS-70 moly paste.

The blade was secured to the adapter plate using quantity 12 UNF 3/4-16, 7-in (17.78-cm) length, Grade 8 steel fasteners on a 30-cm bolt circle that were torqued to 287-ft-lbs (389-N-m) and lubricated with TS-70 moly paste. To allow for internal sensor wiring, a 2-in (5.08-cm) thick steel shim plate with cable slots was positioned between the adapter plate and the blade root as shown in Figure 5.1.

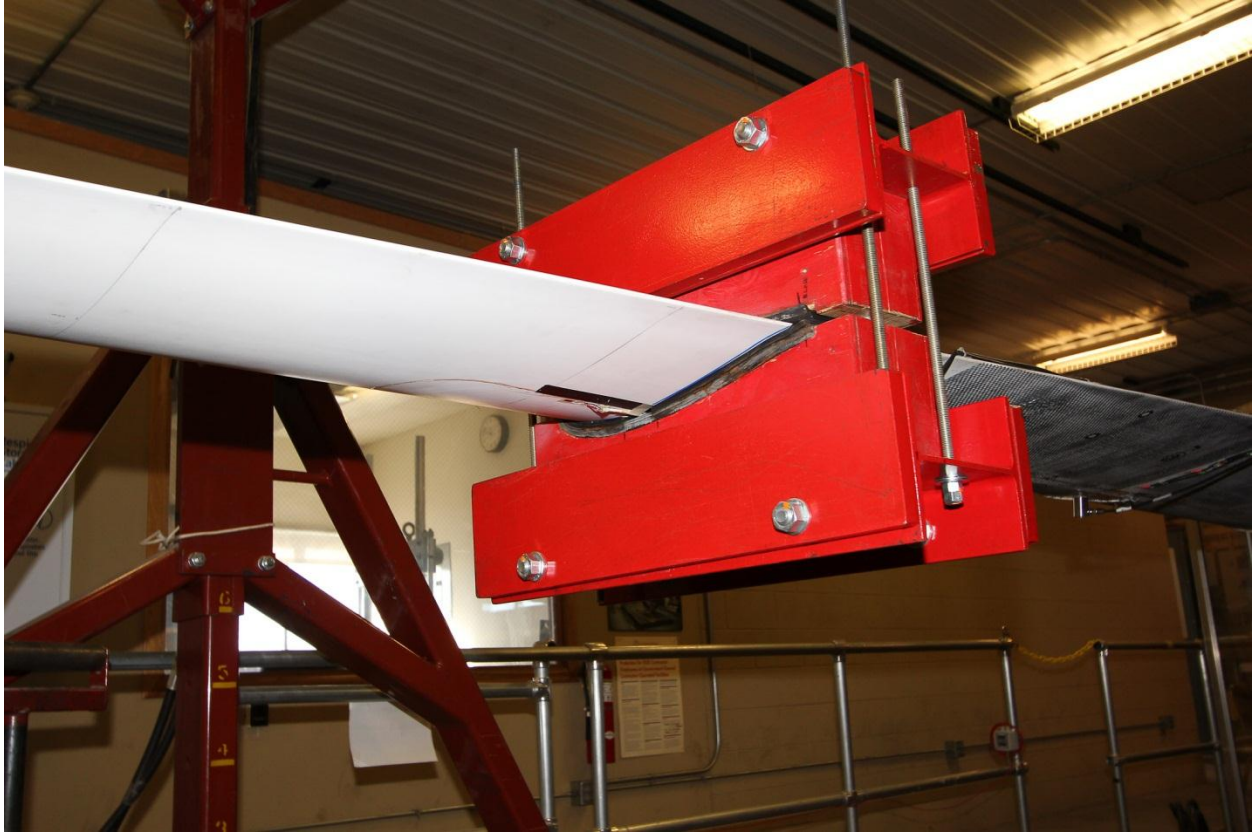
Figure 5.3 – 6.75-m Ballast Saddle

Load saddles are utilized to transmit the inertial loads to the blade and to modify the moment distribution along the span of the blade. The saddles consist of wood forms surrounded by steel frames. The wood forms are constructed from 12.7-cm thick, in the spanwise direction, microlams which are custom fitted to the airfoil sections for that station. A thin strip of rubber is placed between the blade and wood form to protect the blade surface and ensure proper load distribution. The steel frames are constructed from I-beams and clamped together using quantity 4 Grade B7 threaded rods.

Two load saddles were used for this test, one centered at the 1.6-m station and one centered at the 6.75-m station. The UREX test system was mounted to the inboard 1.6-m saddle and the outboard 6.75-m was used as ballast to achieve the prescribed mean and oscillating loads.

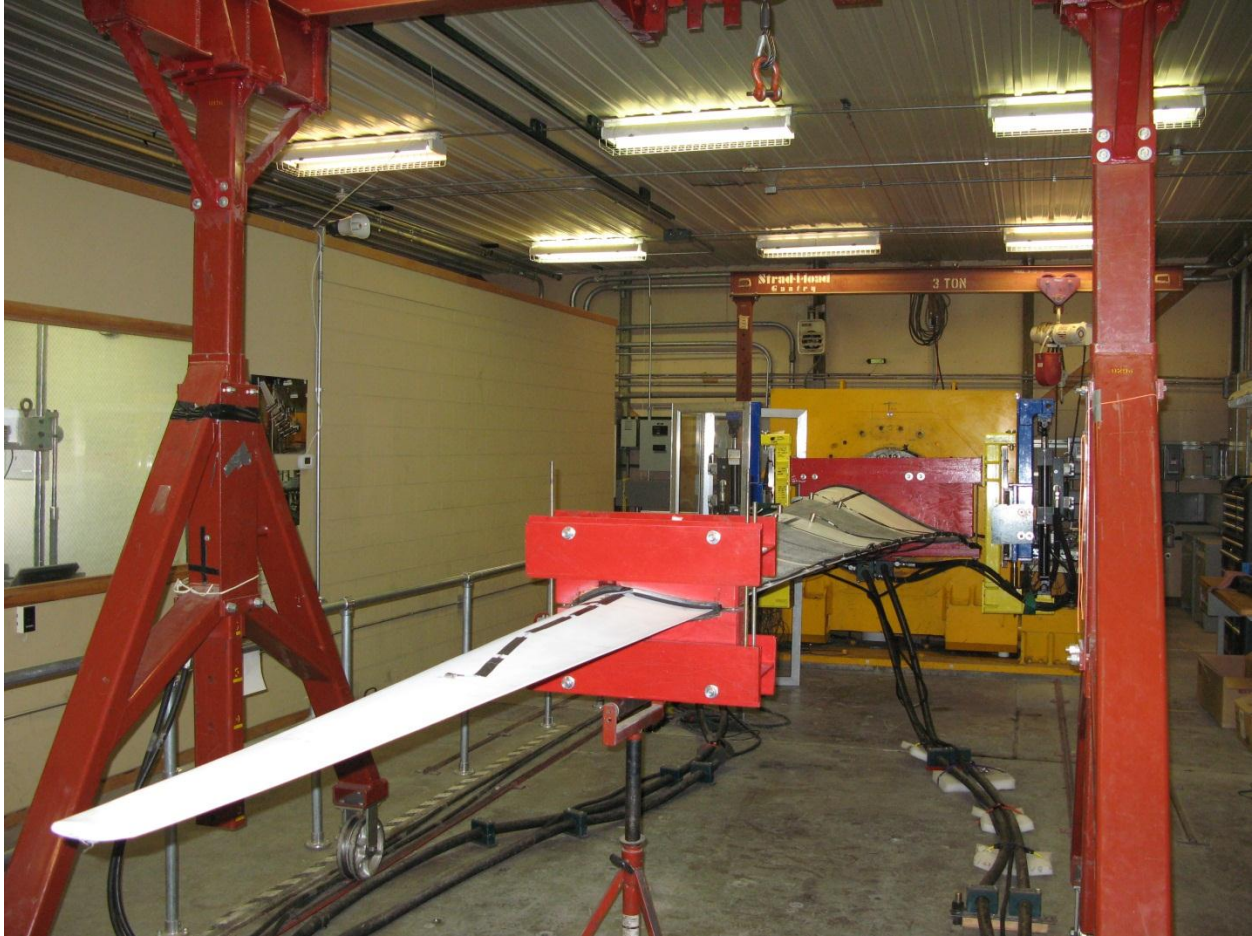
Figure 8.1 – Flapwise Fatigue Test

The laboratory fatigue testing of the UML Defect 9-m wind turbine blade was conducted from November 2011 to March 2012 in the A60 test bay as shown in Figure 8.1. The blade was loaded primarily in the flapwise direction using a resonant excitation method. Applied loads were measured via calibrated strain gages. Matlab scripts were developed for all the post-processing and analysis performed on the data. The raw mean and range data versus cycle count collected for all active channels can be found in Appendix A.

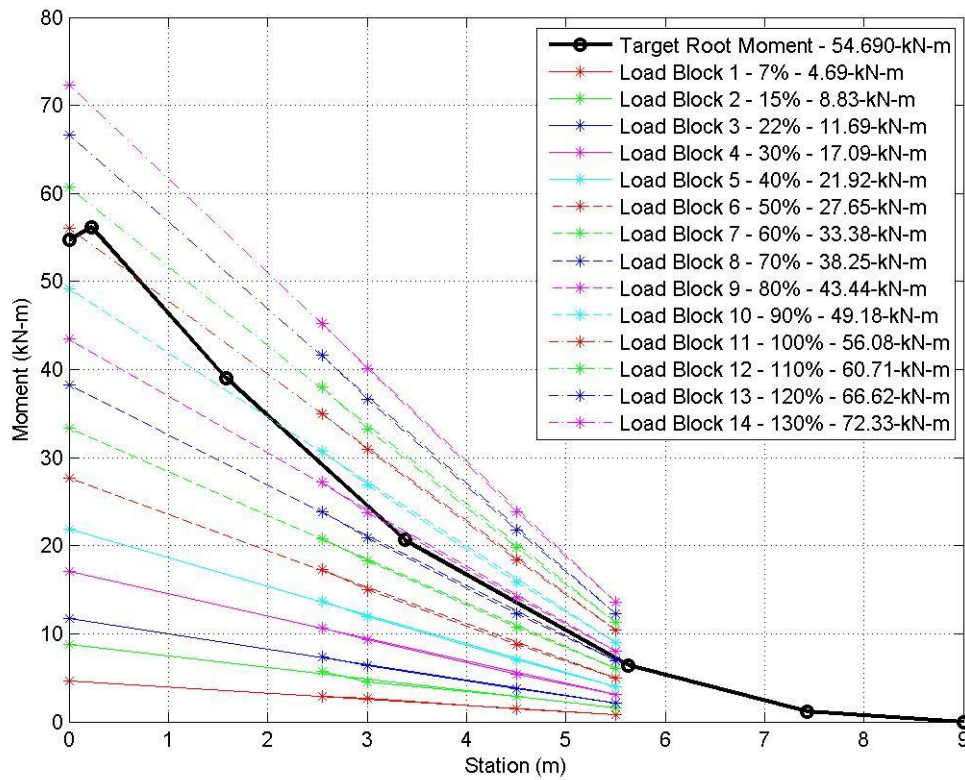
Figure 8.2 – Applied Test Loads

The applied test loads for each load block as compared to the target load are shown in Figure 8.2.

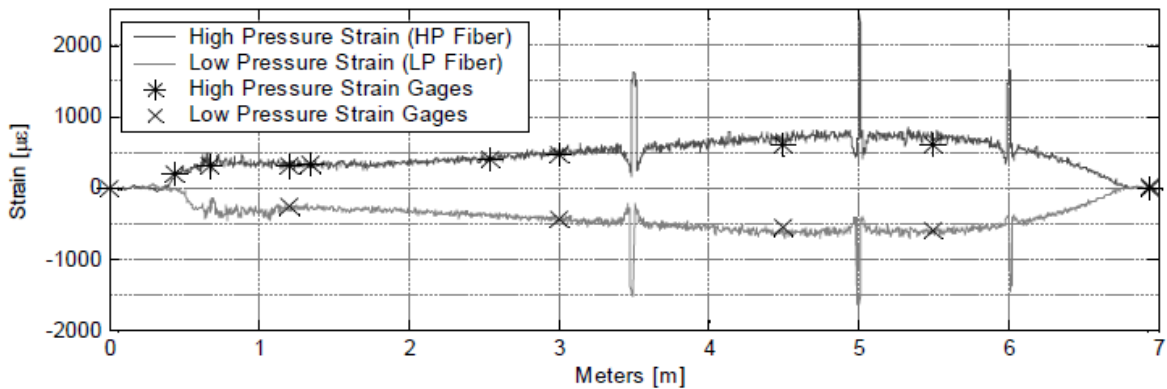
Figure 8.5 – Fiber Optic and Foil Strain Gage Measurement Comparison

Luna Technologies system using fiber optics and UML digital image correlation measurements reported that there were stress risers on the order of 2-3 times in the defect areas (spikes at 2.5, 5 and 6-m) as compared to surrounding areas, as shown in Figure 8.5 [4]. Strain gages used in the primary data acquisition system were located approximately half a meter away from these defects.

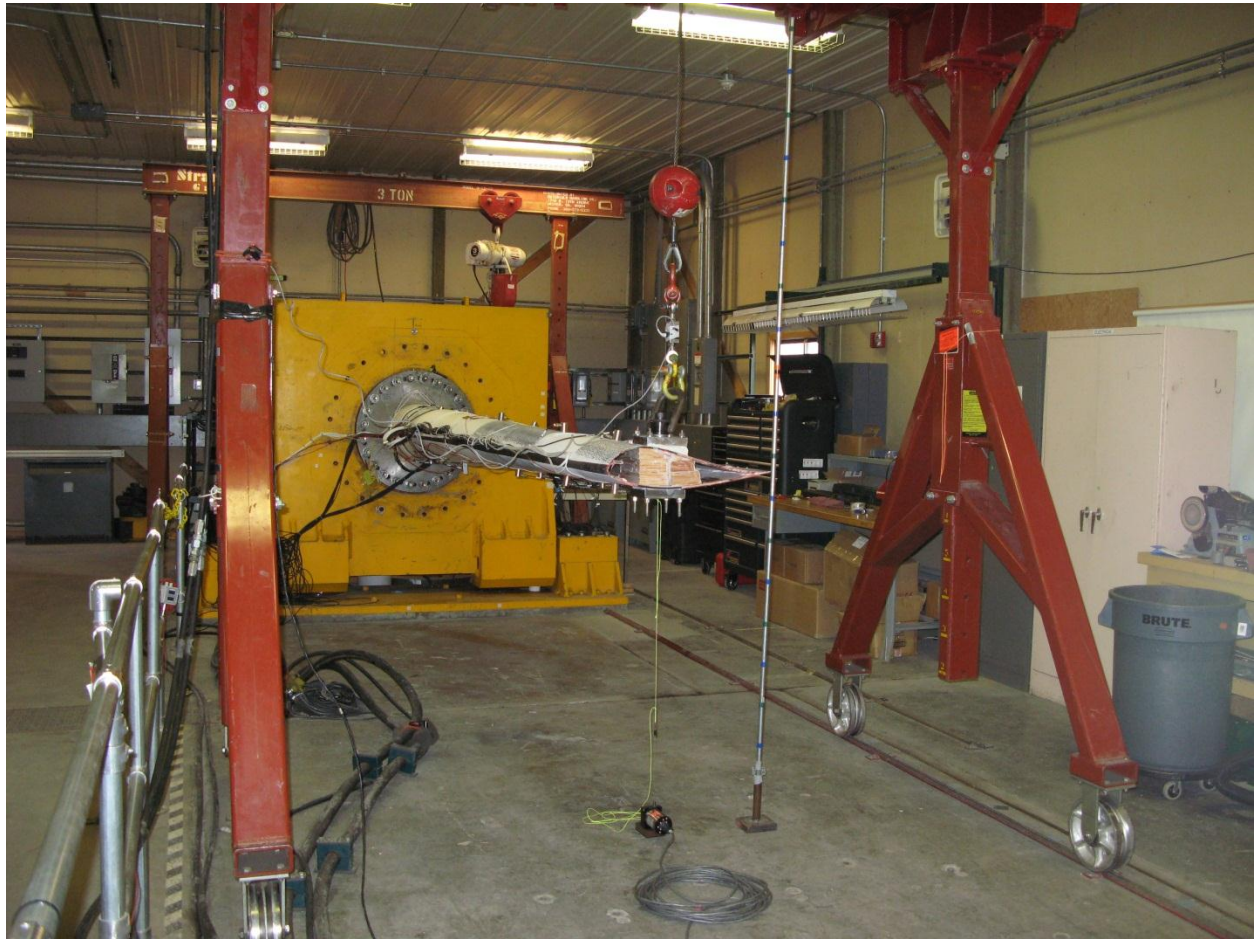
Figure 8.10 – Post Fatigue Failure Residual Strength Flapwise Static Test

After the fatigue test was concluded, a single-point quasi-static load to failure was conducted to obtain additional information about the residual strength of the inboard wave defects located at the 3.5-m station. For this, the blade was cut at the 4.9-m station and the outboard tip section removed.

The test load was introduced to the blade via quasi-static single point load applied at the 4.8-m station with the overhead gantry crane pulling in the negative flapwise direction (LP to HP) as shown in Figure 8.7. The load introduction hardware consisted of a 44.5-kN hoist ring secured to 31.75-mm thick steel plates that was fastened together with 12.7-mm Grade B7 threaded rods. The inside of the airfoil was filled with wood laminates and epoxy for 100-mm on either side of the shear web and 200-mm deep, in order to prevent crushing and minimize airfoil deformation. The threaded rods penetrated through both high and low pressure skins, the wood epoxy filler, and the carbon fiber spar cap on the leading edge side, and were torqued to 40.7-N*m to prevent separation of the plates. The pull point was centered over the shear web.

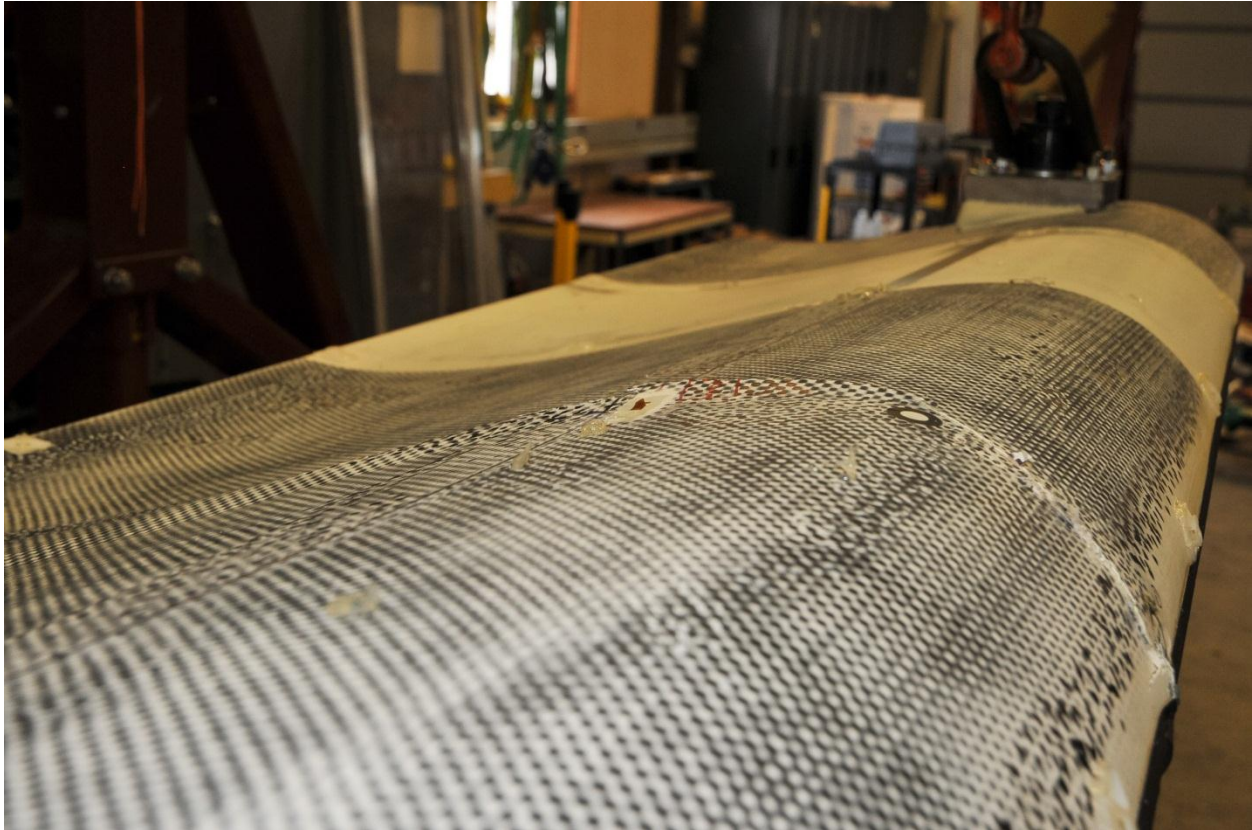
Figure 8.13 – Static Test Buckling Failure (HP Side at 3.5-m Station)

The failure mode appeared as localized buckling at the 3.5-m station on the high pressure surface as shown in Figure 8.13. The crack spanned the entire surface from the leading edge to the trailing edge.

After the fatigue test was concluded, a single-point quasi-static load to failure was conducted to obtain additional information about the residual strength of the inboard wave defects located at the 3.5-m station. For this, the blade was cut at the 4.9-m station and the outboard tip section removed. The blade tip was then sandwiched with steel plates bolted through the spar caps to provide a fixed loading point. The blade was gradually loaded in steps in the negative flapwise direction until a buckling failure was observed at the 3.5-m station on the HP side (in compression for the negative flap loading), which occurred at approximately 115% of the target static loads.
