APPENDIX H

DEFECT DETECTION DURING MANUFACTURE OF COMPOSITE WIND TURBINE BLADE WITH EMBEDDED FIBER OPTIC DISTRIBUTED STRAIN SENSOR

Sandra M. Klute, Alex K. Sang, Dawn K. Gifford, Mark E. Froggatt
Luna Innovations Incorporated
3157 State St.
Blacksburg VA 24060

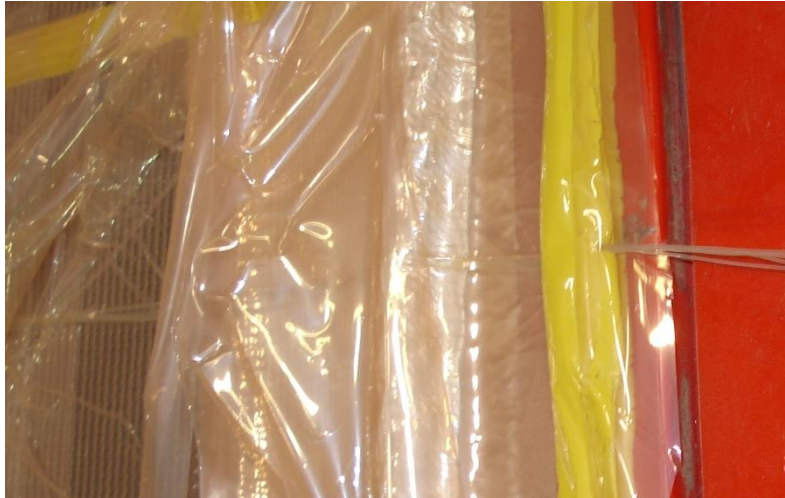
Figure 4. Optical fiber ingress through bag seam at trailing edge for vacuum and infusion.

The wind turbine blade was manufactured using a vacuum assisted resin transfer molding process that uses a vacuum to pull liquid resin into a dry lay-up. In the CX-100 blade the optical fiber ingress through the vacuum bag was accommodated at the trailing edge bag seam where the fibers were sealed in the seam with standard vacuum bagging tape, as seen in Figure 4. For redundancy in the sensing system, both ends of the fibers were terminated with FC/APC optical connectors so that measurements could be made from either end. The fiber egress ends were sealed in a second bag located within the primary bag in the center of the blade for later use, shown in Figure 5. Sufficient fiber was left to run these connectors out through the blade root after final assembly. The resin transfer process utilized two spiral wrap resin fill tubes, one dedicated to the root fill and the other to the fill of the remaining blade section. Both fill tubes ran along the blade spanwise at approximately the half chord location such that resin flowed quickly out towards the leading and trailing edges simultaneously.

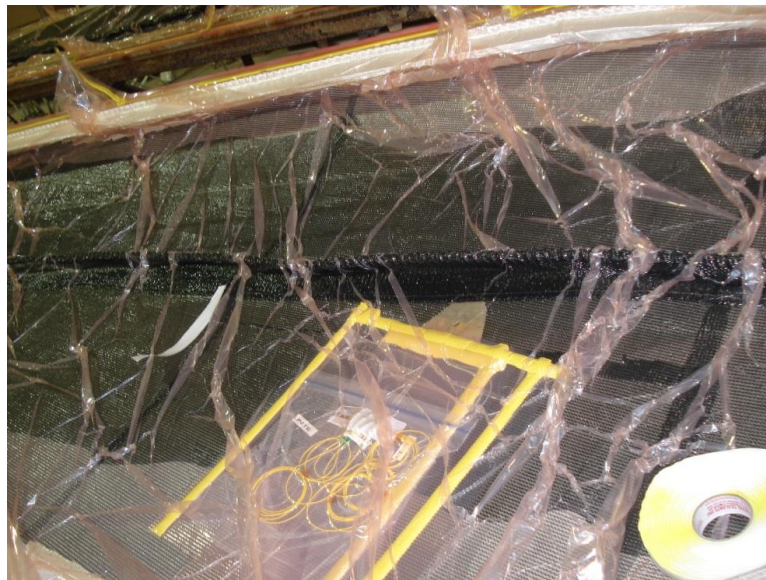
Figure 5. Fiber egress ends terminated with FC/APC connectors and double bagged during the infusion process.

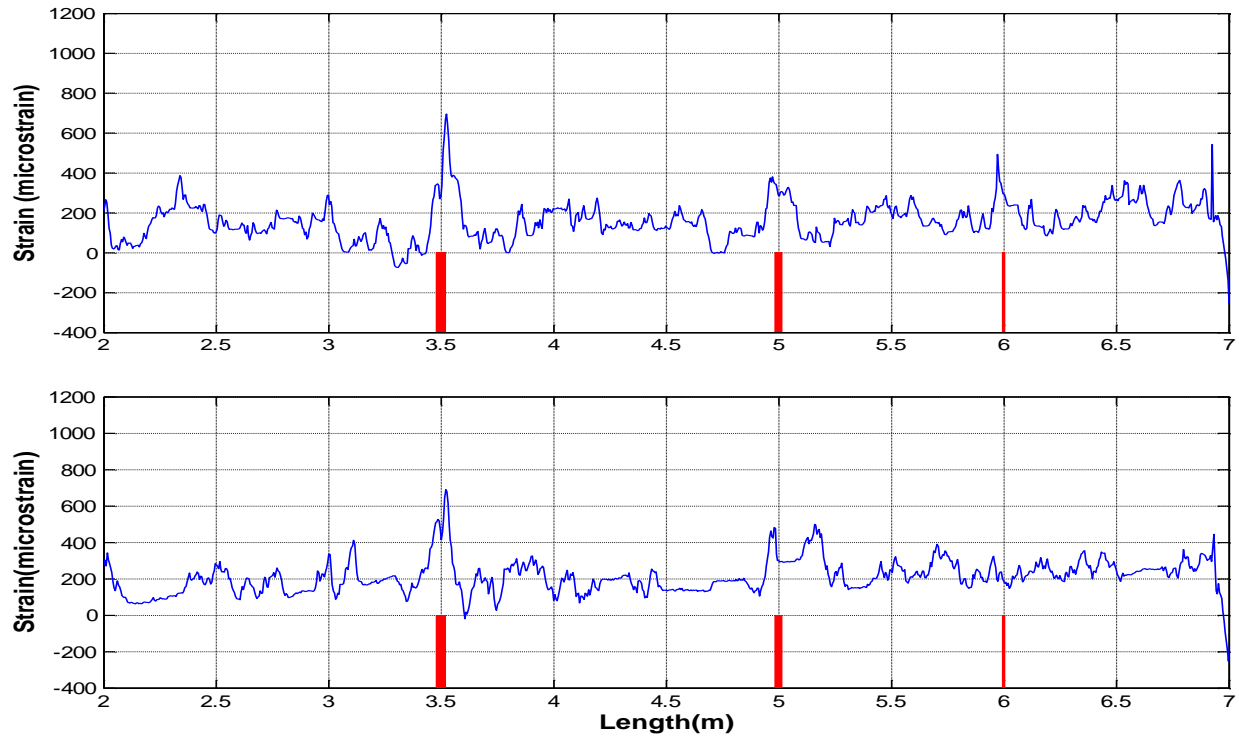
Figure 7. Distributed strain in optical fiber embedded in composite material directly above defects (ch 2) along leading edge (upper) and trailing edge (lower) of spar cap after vacuum.

Distributed strain measurements along the leading and trailing edge spar cap locations are shown in Figures 7-9 for fibers 2-4, at varying depths throughout the layup. Strain in the two triax layers directly above the defects (Figures 7 and 8) shows smaller peaks at the defect locations compared with those seen in the fiber under the defects (Figure 6).

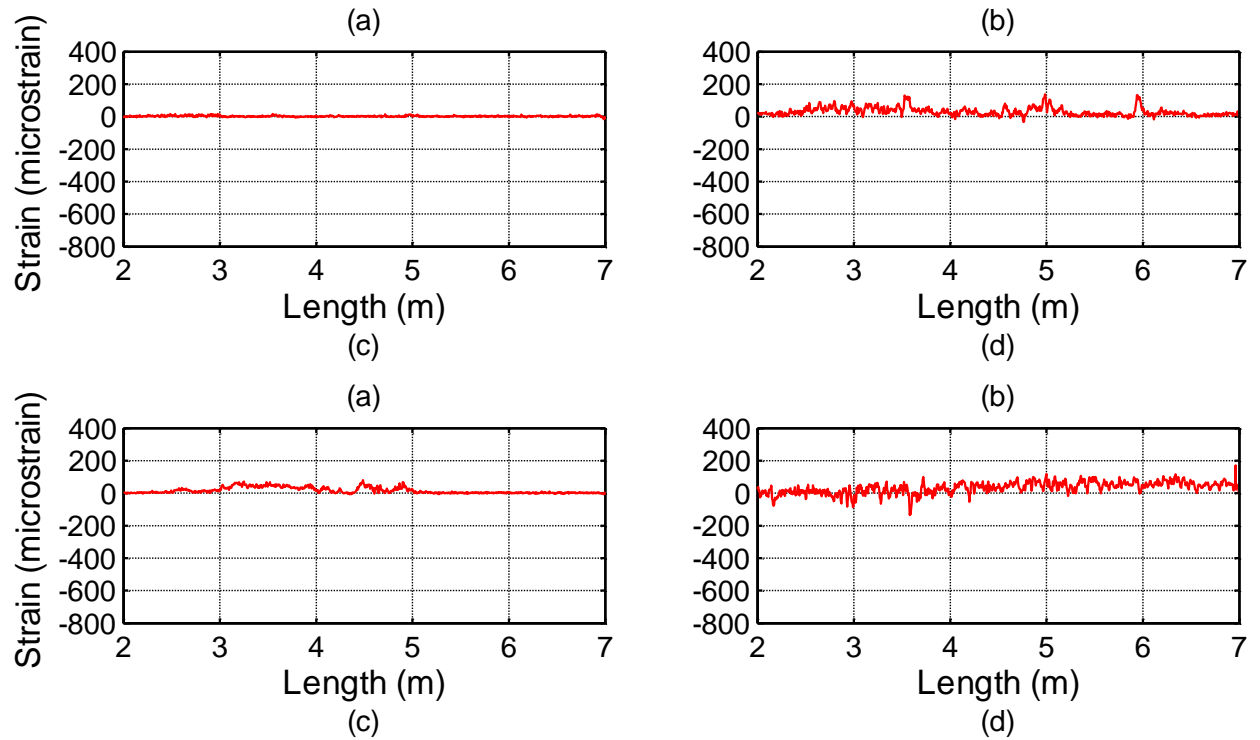
Figure 13. Distributed strain in optical fiber embedded in Layer 1 along leading edge (upper) and trailing edge (lower) of spar cap during infusion, times $t =$ (a) 0:20:30 and (b) 0:21:30.

Figure 14. Distributed strain in optical fiber embedded in Layer 2 along leading edge (upper) and trailing edge (lower) of spar cap during infusion, times $t =$ (a) 0:20:30 and (b) 0:21:30.

Figure 15. Distributed strain in optical fiber embedded in Layer 3 along leading edge (upper) and trailing edge (lower) of spar cap during infusion, times $t = (a) 0:20:30$ and $(b) 0:21:30$.

Figure 16. Distributed strain in optical fiber embedded in Layer 4 along leading edge (upper) and trailing edge (lower) of spar cap during infusion, times $t = (a) 0:20:30$ and $(b) 0:21:30$.

Data from fibers located in the four layers of the blade are shown in Figures 13-16 for the leading edge (upper) and trailing edge (lower) spar cap regions at times $t =$ (a) 0:20:30 and (b) 0:21:30. The infusion can be seen to begin at $t = 0:20:30$ in Layers 4 and 3 of the trailing edge, and progress through Layers 2 and 1 of the trailing edge by $t = 0:21:30$. The spiral wrap feed line was located in close proximity to the spar cap. It appears from the strain data that it was located closer to the trailing edge; the trailing edge data shows infusion prior to the leading edge. It also appears that the resin is first introduced at a blade station of approximately 3 meters.
