FINAL TECHNICAL REPORT
Effect of Manufacturing-Induced Defects on
Reliability of Composite Wind Turbine Blades

U.S. Department of Energy
Award No. DE-EE0001374 ARRA Funding

UML Report # S51900000011598

University of Massachusetts Lowell

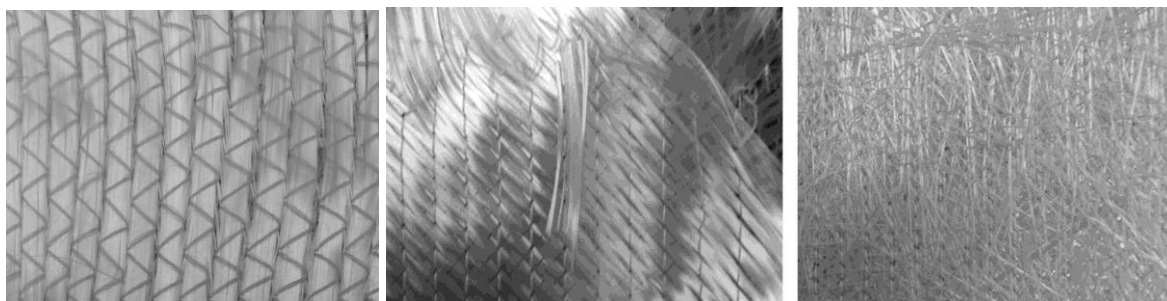
Figure 2.1.1 Examples of non-crimp, double bias non-crimp, and random mat fabrics

The credibility of the finite element simulations is dependent upon an experimental characterization of the dry fabric material as well as the cured composite architecture. For the CX-100 blades, six different non-crimp fabrics (NCFs) were studied (Fig. 2.1.1).

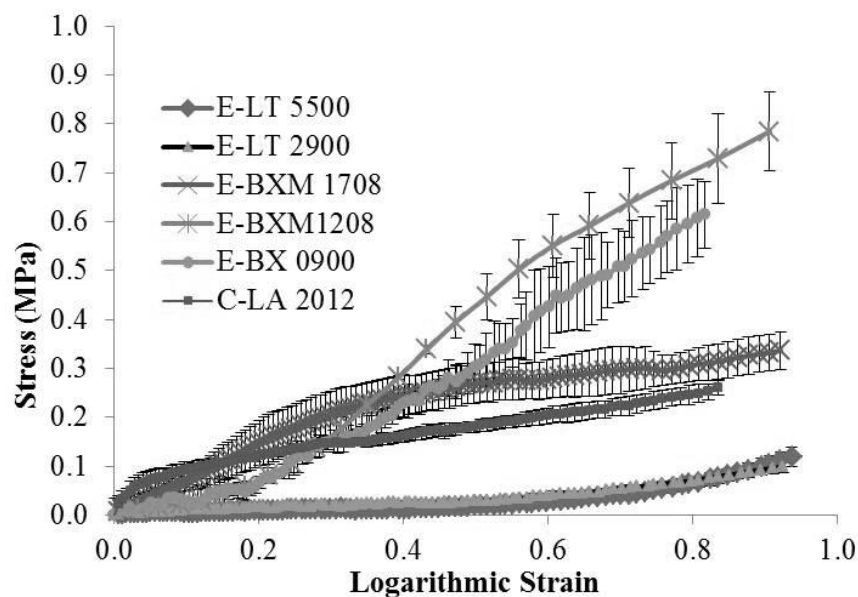
Figure 2.1.3. Shear Response of CX-100 Non-Crimp Fabrics

The differences in shear behavior of the NCFs can be seen in Figure 2.1.3. Such differences can have an effect on the formation of wave defects and general formability of the material into the mold.

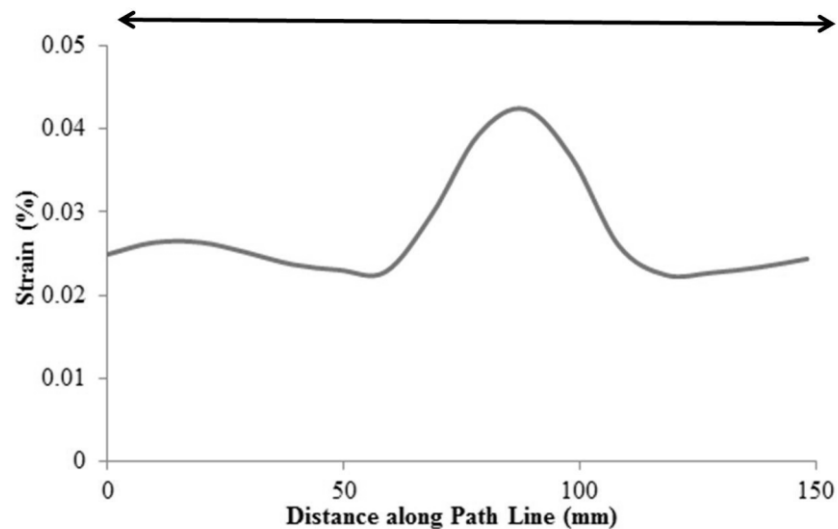
Figure 2.3.5. Finite element model results: Strain along the line of interest drawn at the location of a wave defect in the blade

As was done with DIC measurements in Figures 2.3.2 and 2.3.3, a double-arrow line of interest can be drawn across the LP surface of the finite element model of the blade (Figure 2.3.4) to compare the magnitude of the nominal strain away from the defect to the magnitude of the amplified strain at the location of the defect (Figure 2.3.5).

Despite using only the structural properties of an E-LT 5500 laminate, the finite element model showed the amplification of strain at the location of the three defects. This amplified strain was similar to typical measurements made using a digital image correlation system, providing support for the validity of the model.

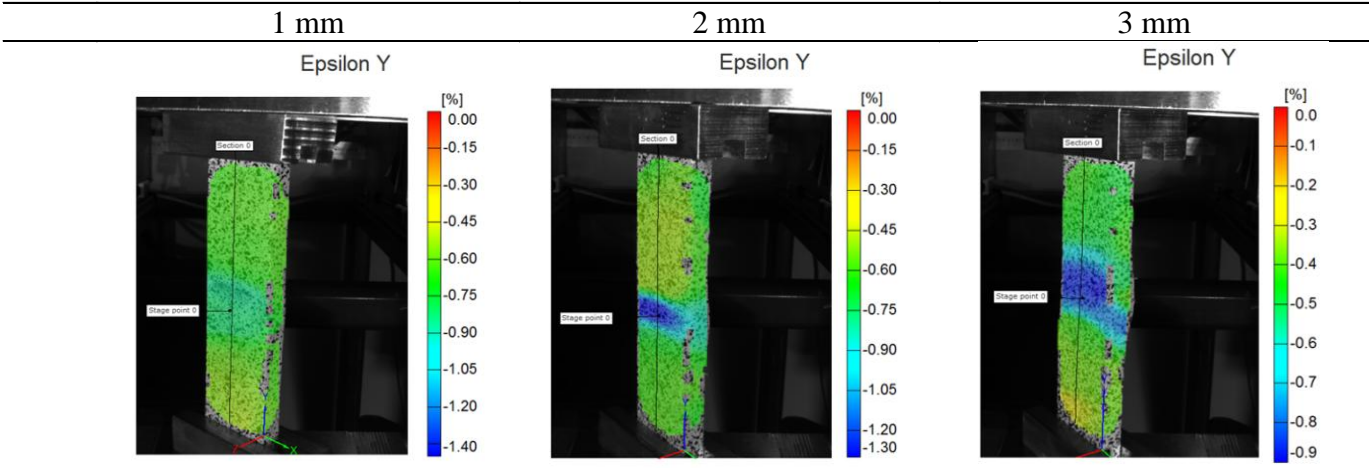
Figure 2.4.4. Examples of DIC strain measurements during compression tests with aspect ratio of 10, but differing wave amplitudes.

Three-dimensional Digital Image Correlation (3D DIC) measurements and finite element (FE) models were used for data comparison and interpretation purposes (Figure 2.4.4). As the

amplitude of the embedded wave defect increased, the level of strain amplification visibly increased on the surface near the defect, indicating that perhaps the wave amplitude is a more critical defect parameter in terms of compressive strength than the aspect ratio.

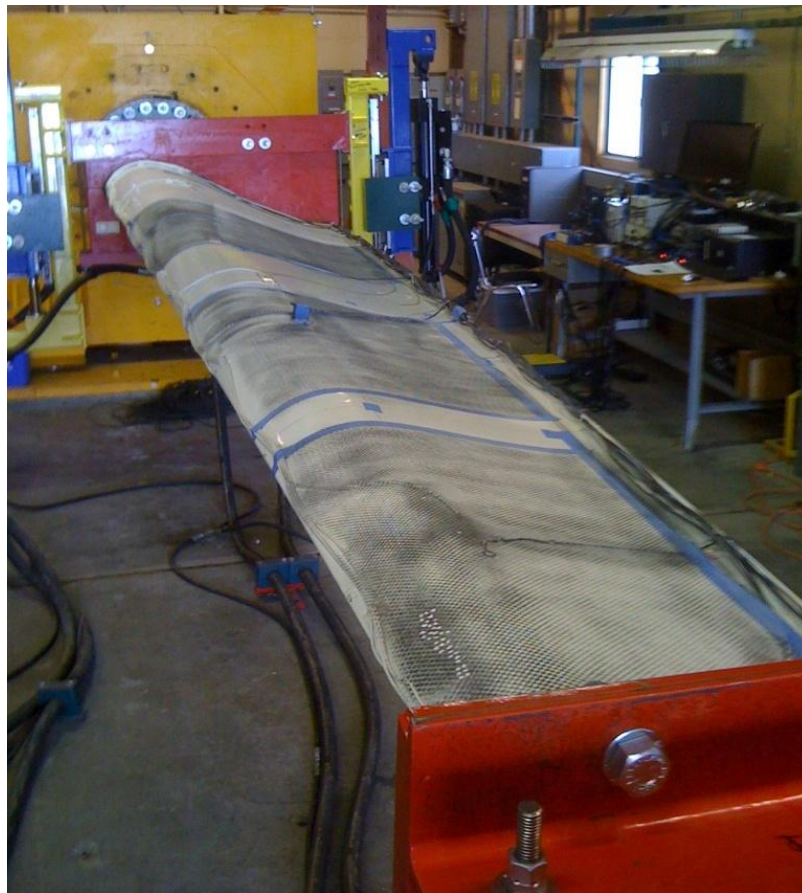
Figure 2.5.1 LANL defect-free blade test setup at NREL with DIC patterning.

Digital Image Correlation (DIC) measurements were made on three separate TPI Composites CX-100, 9-meter, wind turbine blades (Sandia “Sensor Blade”, LANL Blade and UMass Lowell Defect Blade). Figure 2.5.1 shows the LANL blade with the DIC patterning on the surface.

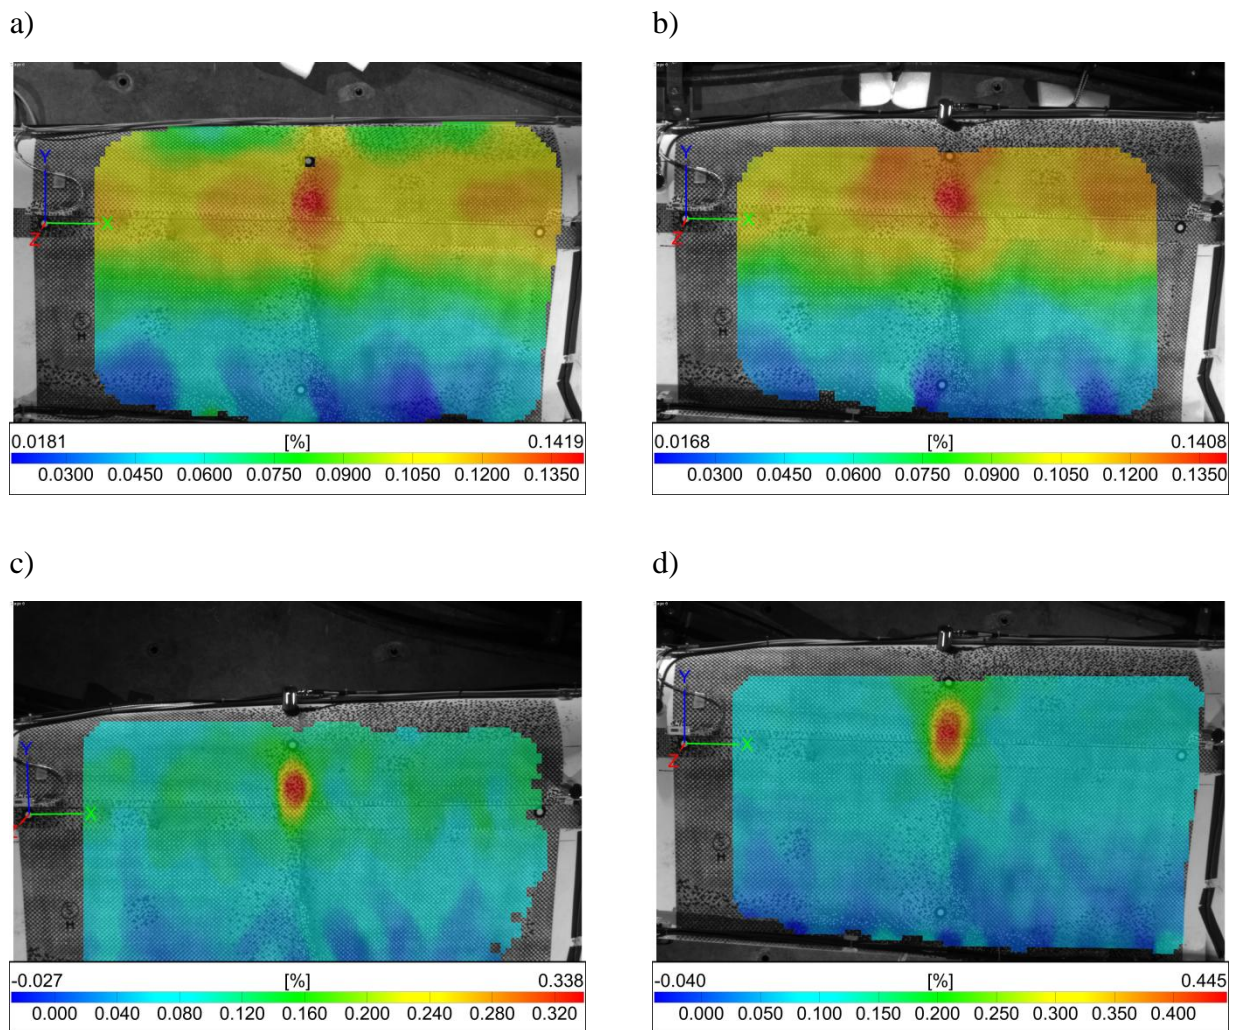
Figure 2.5.2. Strain contour plots for the 5.0-meter section at a) 0 cycles; b) 25,603 cycles; c) 755,049 cycles; d) 1,803,350 cycles.

For the UMass Lowell defect blade, the DIC was able to clearly show the location of the defect. As the blade was cycled, the strain amplification in the vicinity of the defect became

even more apparent as is shown in Figure 2.5.2 for the 5m high pressure side, defect location (area where failure first occurred).

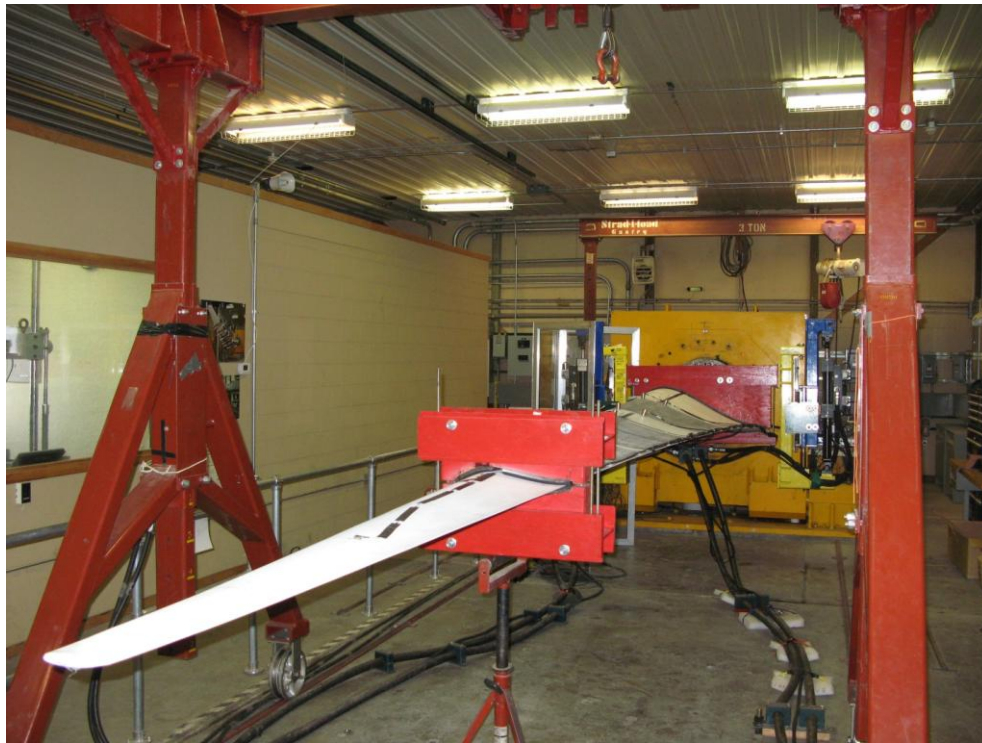
Figure 2.6.1 NREL flapwise fatigue test setup for 9-meter UMass Lowell defect blade.

The report in Appendix F from NREL describes the laboratory fatigue testing of the UML Defect 9-m wind turbine blade conducted at the National Wind Technology Center (NWTC) in Colorado. The test was performed with the blade cantilevered to the 1,360-kN-m yellow test stand (Figure 2.6.1). Unique to this blade were manufactured wave defects that were fabricated in the spar cap laminates at the 3.5-m, 5-m, and 6-m stations, on both the high pressure (HP) and low pressure (LP) sides. An accelerated 1-million cycle design life fatigue load was applied to the blade before increasing loads in discrete steps up to 130% of the target fatigue loads, at which point a 2.5-cm long crack was observed at the 5-m station on the HP surface spar cap, biased towards the leading edge (LE). (Figure 2.6.2) The test ran for approximately 1.9-million cycles before the failure. After the fatigue test was concluded, a single-point quasi-static load to failure was conducted to obtain additional information about the residual strength of the inboard wave defects located at the 3.5-m station.

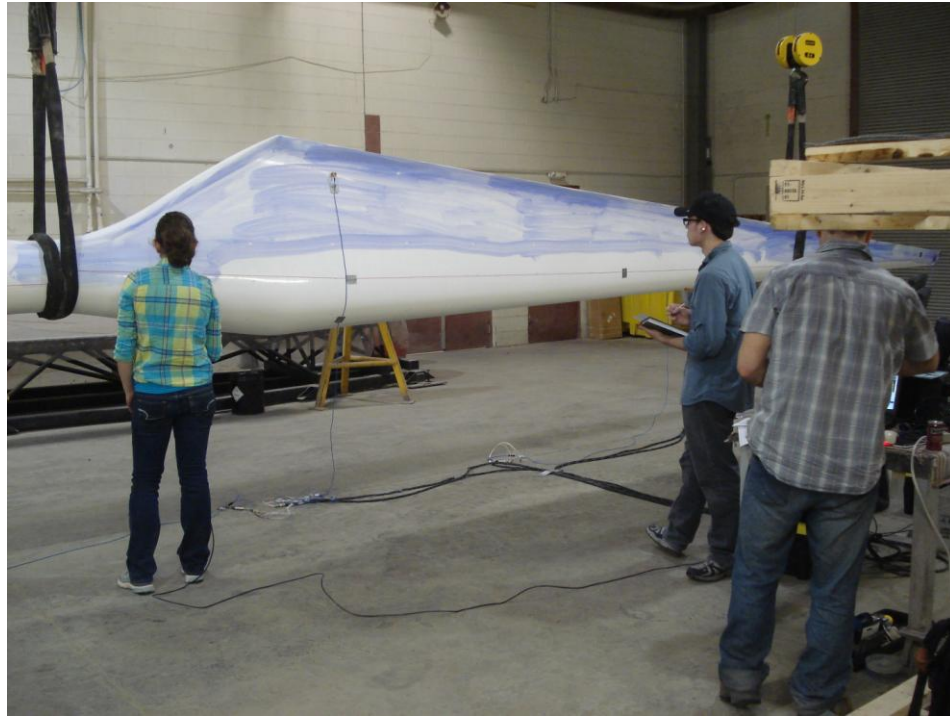
Figure 2.7.1 Free-free modal test setup for 9-m UMass Lowell defect blade at TPI.

Figure 2.7.1 shows the UMass Lowell defect blade being tested at TPI with accelerometers attached. The blade was tested in a free-free condition and was impacted with a calibrated impact hammer. Five (5) tri-axial accelerometers were attached to the high pressure side of the blade.

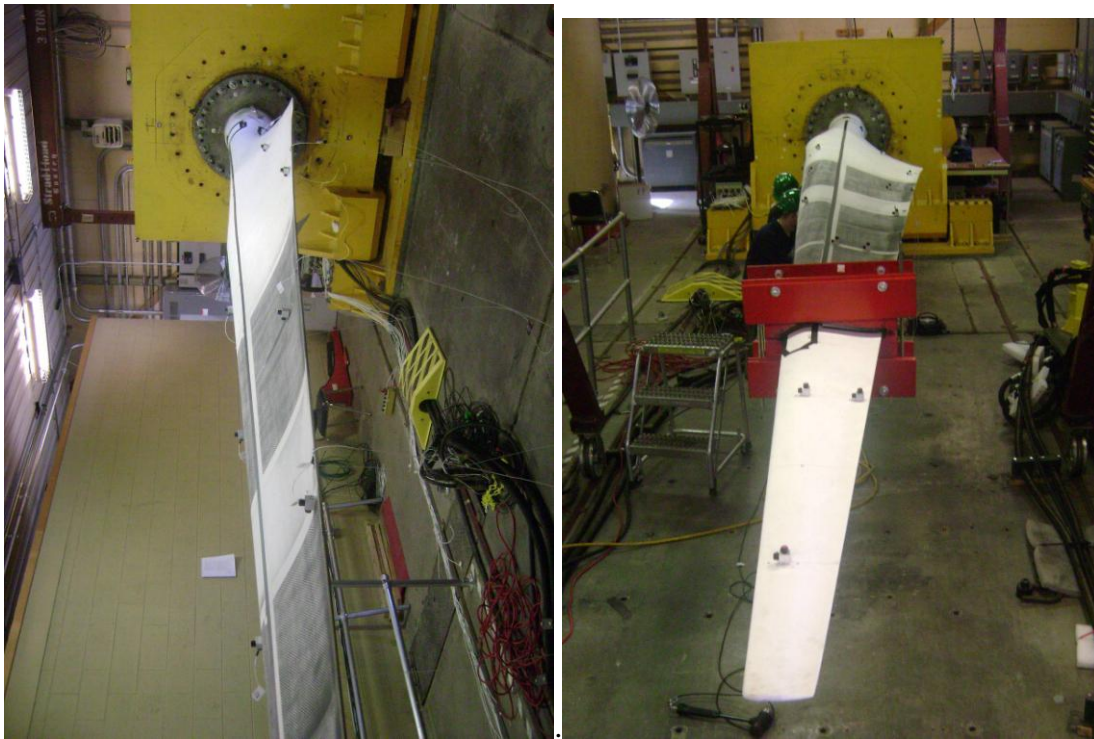
Figure 2.7.2. 9-m UMass Lowell defect blade clamped (a) without, and (b) with the saddle at NREL

At NREL, measurements were taken on the UMass Lowell blade while clamped in the test fixture, both without and with the support saddle (Figure 2.7.2)
